# Volume II

## Appendix D.7

### Working Scenario

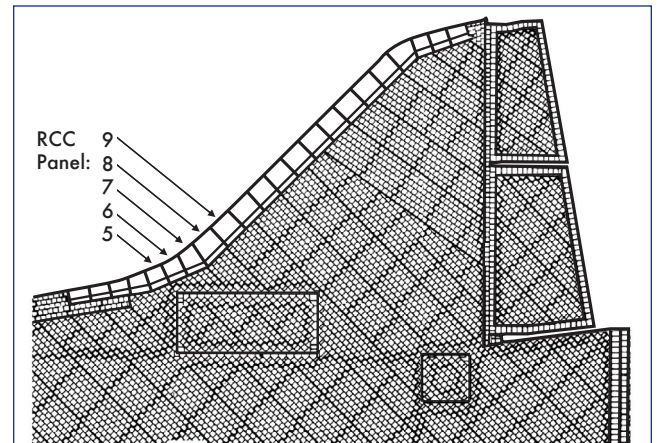
Several approaches were taken to assess the area of left wing damage. The efforts included launch video and photograph analysis, review of launch MADS data, debris transport analysis, forensic analysis of debris found in Texas, wire bundle burn through analysis, and aero/thermal modeling of the entry. The data indicate that the area of the highest probability of damage to the left wing was between RCC panels 5 and 9, with the most likely damage occurring on the lower side of RCC panel 8 or an adjacent Tee seal. The damage was most likely equivalent in size to a 6 to 10 inch diameter hole or area broken from the RCC panel or an adjacent Tee seal. Figure 3-4 shows the area of highest probability of wing damage and Table 3-1 shows the methods used to determine the damage.

Figure 3-4. Area of most likely wing damage.

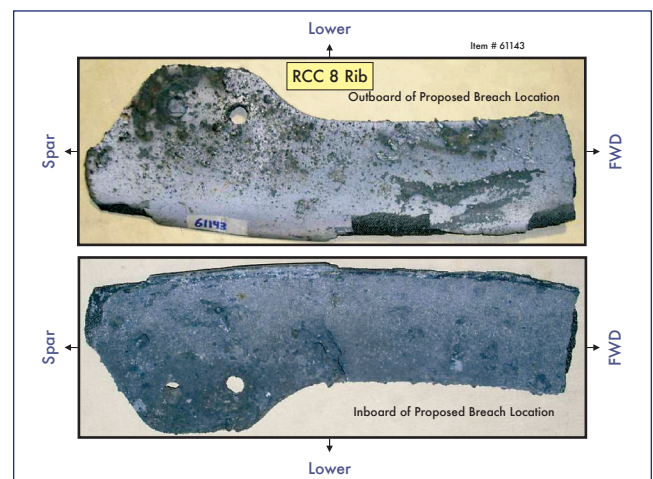
Figure 5-3. Samples of severe slag deposition on the panel 8 rib.

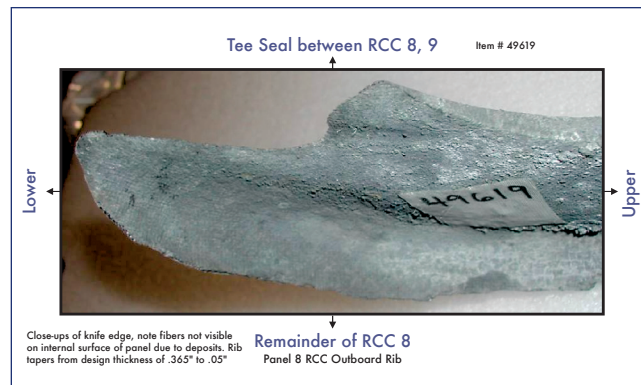
This forensics analysis further corroborates the breach location to be the lower portion of RCC panel 8 below the apex, approximately midway between the apex and where the RCC panel meets the carrier panel. Based on the flow

Figure 5-4. Example of rib erosion.

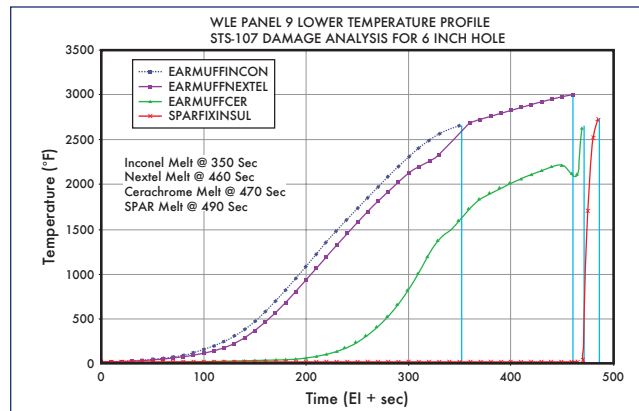
(EI + 490 sec.). This time would be accelerated slightly for a larger diameter hole. The results of this thermal model are shown in Figure 5-30.

Figure 5-30. Thermal model prediction of wing spar burn through.

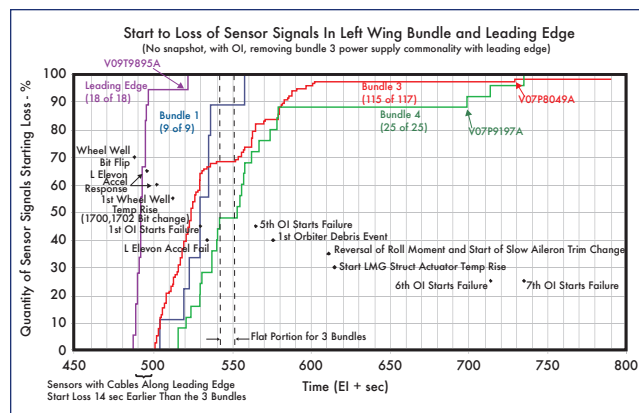
square foot per second (equivalent to the flight environment at about 8:50 EST, EI ~ 351 sec). During the test, the aluminum plate hole grew from 1 inch in diameter to 5 inches in diameter in approximately 13 seconds. This was consistent with thermal math models developed to analytically predict hole growth. A wire bundle placed 15 inches from the heat source showed very rapid erosion after the hole grew to 5 inches in diameter. The measurement losses in this bundle were very consistent with those observed for wire bundle number 3 (see Figure 5-34). The hole would have grown to a larger diameter; however, the test set-up provided a heat sink that eliminated further hole growth. Overall, the test indicated that a hole in the aluminum honeycomb would grow rapidly, allowing a substantial plume to destroy the wire bundles on the wheel well wall.

Figure 5-34. MADS data failure due to wire burning.

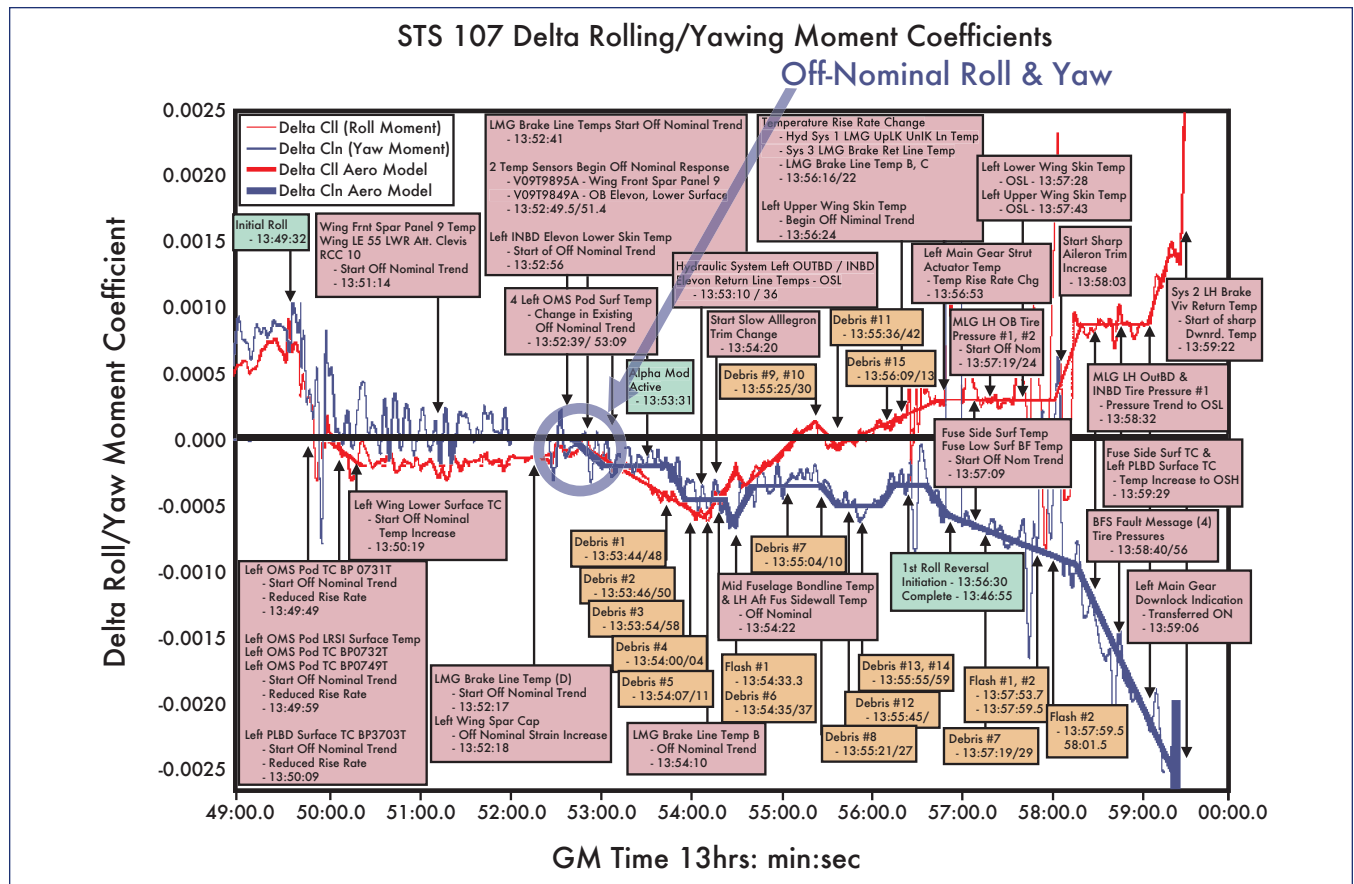
At 8:53:39 (EI + 570 sec.), four left OMS temperature measurements also exhibited an unusual temperature rise. This temperature rise is attributed to shifting of the left wing lead-

Figure 5-43. First noted off-nominal aero event.

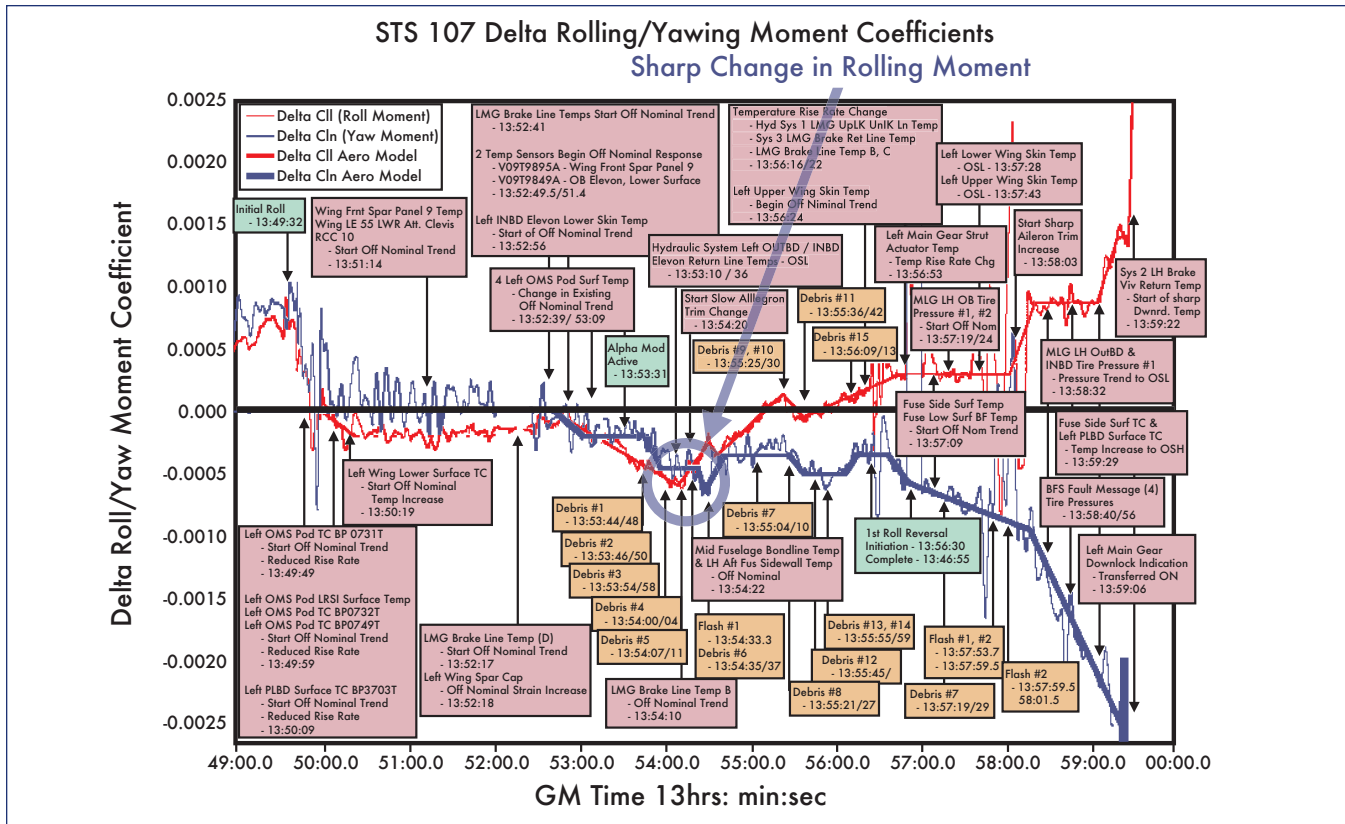
There are several theories that attempt to explain this response including a change in the wing camber or shape due to deformation and a lower wing recession, caused by the loss of much of the support structure internal to the wing. Wing recession here is in reference to structural deformation of the wing surface. In this case, one or more areas on the lower wing form a more concave shaped depression of wing skin and tiles as a result of the structural support in those areas being weakened or lost. A structural analysis of both wing deformation due to the loss of three ribs internal to the wing, and the wing recession concept was performed.

Figure 5-44. Sharp change in rolling moment.

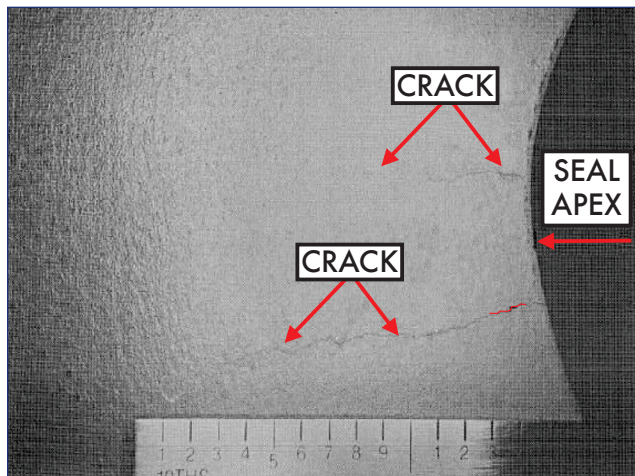
Figure 10-9. Tee seal cracking.

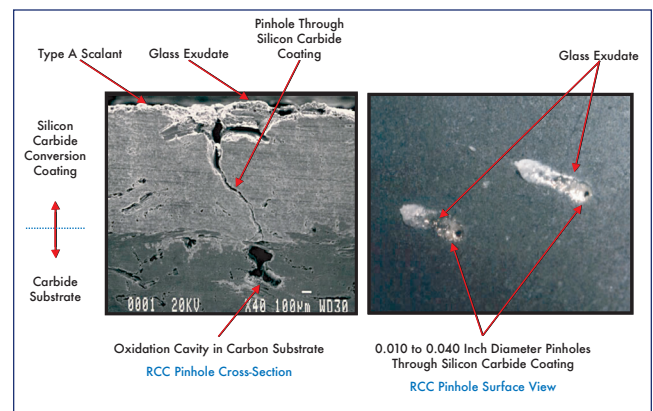
Figure 10-10. RCC pinholes.

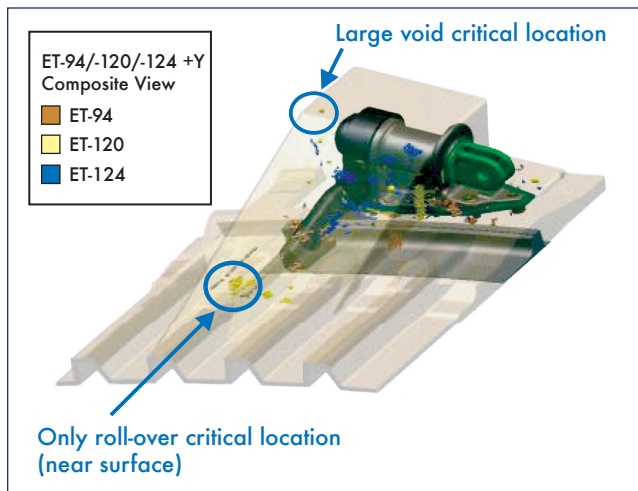
Figure 11-11. Defects found at critical locations.

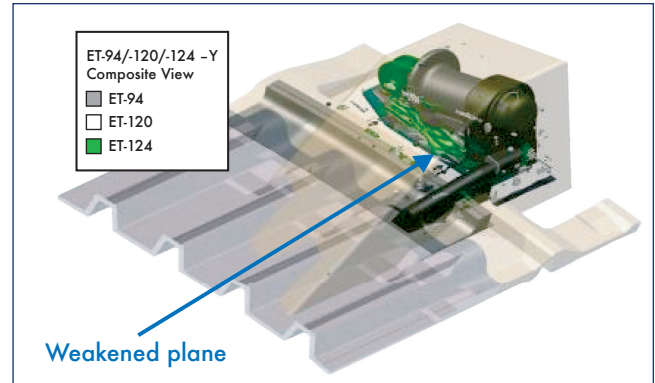
Figure 11-12. Weakened plane defect found.
