# COLUMBIA

## ACCIDENT INVESTIGATION BOARD

REPORT VOLUME II  
OCTOBER 2003

## D.a SUPPLEMENT TO THE REPORT

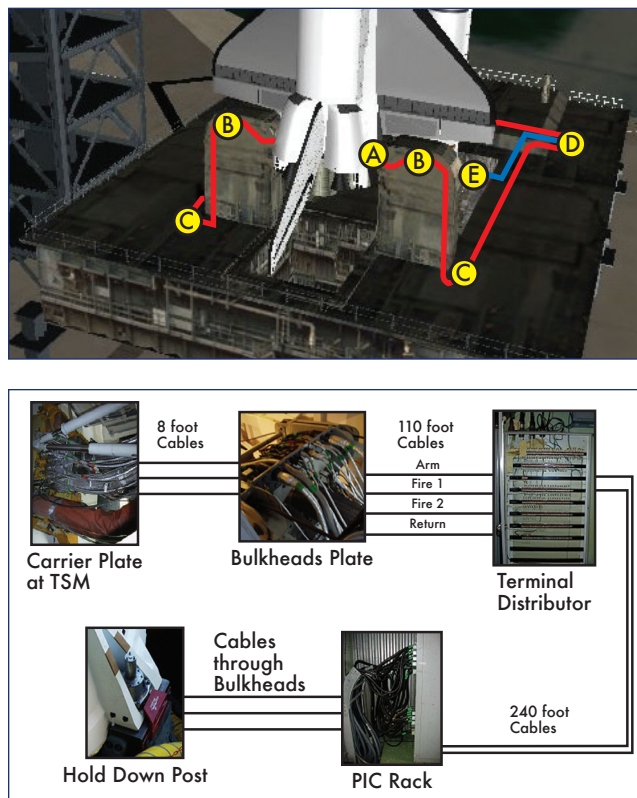
Figure S-1: Hold-Down Post/External Tank Vent Arm Systems diagram with nomenclature below (Note: This figure was not included in the final report Section 10.9; it is provided here for clarity.)

The signal to fire the HDP/ETVAS begins in the General Purpose Computers and goes to both of the Master Events Controllers (MECs). (See Figure S-1 for system routing.) MEC 1 communicates this signal to the A system cable, and MEC 2 feeds the B system. The cabling then goes through the Mobile Launch Platform mast to the Pyrotechnics Initiator Controllers (PICs; there are 16 PICs for A and B Hold-Down Posts, and 4 for A and B External Tank Vent Arm Systems); it then goes to each Solid Rocket Booster and Hold Down Post External Tank Vent Arm System. The A system is hard-wired to one of the initiators on each of the four nuts (eight total) that hold the Solid Rocket Booster to the Mobile Launch Platform. The B system cabling is hard-wired to the secondary initiator on each nut. The A and B systems also send a duplicate signal to the External Tank Vent Arm System. Either Master Events Controller will operate if the other or the intervening cabling fails. To verify cabling integrity, a continuity and ohms check is performed before each launch.

A post-launch review of STS-112 indicated that the A system Hold-Down Post and ETVAS PICs did not discharge. Initial troubleshooting revealed no malfunction, leading to the conclusion that the failure was intermittent. An extensive analysis was initiated, with some 25 different potential fault chains considered as the source of the A-system failure.

- NASA should evaluate a redesign of the Hold-Down Post Cable, such as adding a cross-strapping cable or utilizing a laser initiator, and consider advanced testing to prevent intermittent failure.
