# Volume II

## Appendix D.7

### Working Scenario

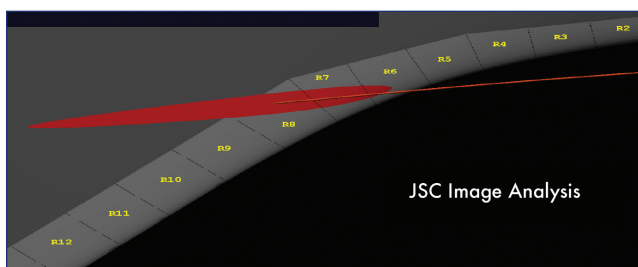
Video and Computer-Aided Design (CAD) analysis determined that the most likely impact location was leading edge RCC panels 6 through 8 (Figure 3-5). Due to the foam size, RCC panels 5 and 9 must also be included in this impact zone. The best estimate of the foam size, based on imagery measurements, is 21 to 27 inches long and 12 to 18 inches

Figure 3-5. Multiple analyses determine foam impacted lower RCC panels 6 through 8 area.

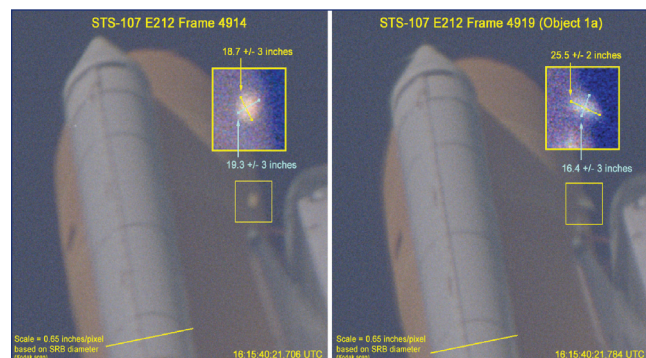
wide. The precise foam shape and thickness cannot be determined from the available imagery; however, a reasonable estimate is that it was a plate-like shape and several inches thick. The foam tumbled at a minimum rate of 18 times per second based on the imagery, although the actual rate may never be known more accurately. Figure 3-6 illustrates a portion of the photographic analysis techniques used to determine the size of the foam.

Figure 3-6. Photographic analysis techniques determined foam size: debris appears almost circular in frame 4914 and elongated in frame 4919.

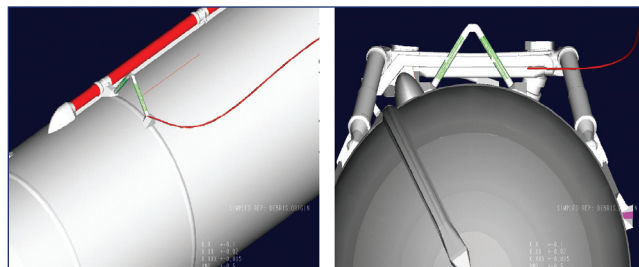
There is significant visual and debris trajectory information to implicate the left bipod ramp area as the source of debris. In Figure 3-9, the red line depicts the estimated foam trajectory as it moved from the bipod ramp area toward the left wing. In addition to locating the impact in the RCC panels 6 through 8 region, the video analysis has also shown that the impact was below the apex of the RCC panels since no foam or post impact debris was observed to traverse over the top of the wing. This is indicative of an impact below the wing leading edge aerodynamic stagnation line (Figure 3-10). The stagnation line, or dividing streamline, is the line along the leading edge of the wing where the airflow comes to rest; above this line, airflow moves over the upper wing surface and below this line, the airflow moves over the lower wing surface.

Figure 3-9. Multiple analyses indicate foam is from ET left bipod area. Red line depicts the estimated foam trajectory as it moved from the bipod ramp area toward the left wing.

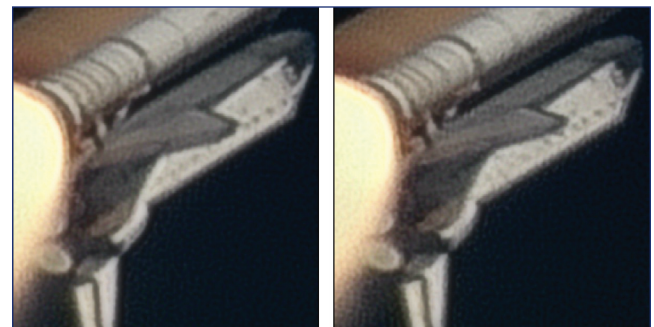
Enhancements of the ascent video indicated there was no discernable damage to the orbiter wing leading edge or lower tile surface. Figure 3-11 is a sample of these video enhancements. The figure compares 30 pre-impact integrated video fields with 21 post-impact integrated video fields. Based on these enhancements, photo experts have been unable to determine or quantify any damage to any portion of the orbiter vehicle as a result of the impact.

Figure 3-11. Pre-impact vs. post-impact shows no observable damage within the resolution limits.

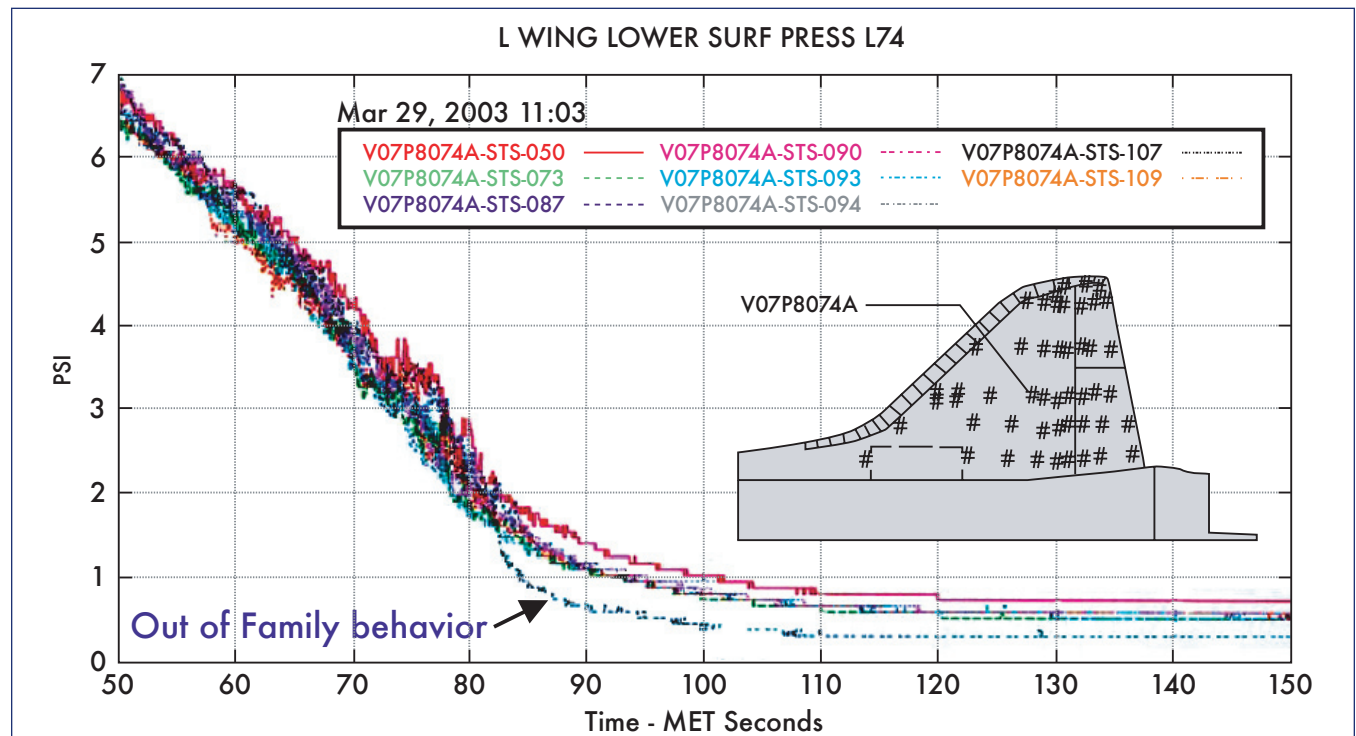
There are two other indications that the foam impact occurred in the panels 6 through 8 area. Two Modular Auxiliary Data System (MADS) lower surface pressure measurements behaved anomalously immediately after the time of the impact. Figure 3-13 shows the location of these measurements along with possible areas for post-impact debris re-contact in the vicinity of the sensors. The unusual behavior of one of the sensors is shown in Figure 3-14.

Figure 3-14. Unusual behavior of pressure sensor V07P8074A.

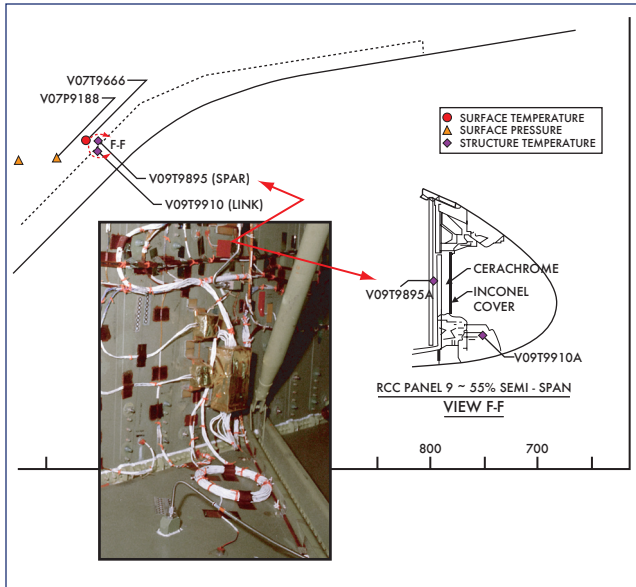
Additionally, there is another MADS measurement that had an off-nominal signature during the ascent timeframe. The temperature sensor on the leading edge spar behind RCC panel 9 showed a slightly higher temperature rise than seen on any previous *Columbia* flight. Figure 3-15 shows the location of the temperature sensor behind the wing leading edge spar inside the wing. The slight temperature rise can be seen in Figure 3-16. Note that most flights show a small rise in this temperature during ascent due to aerodynamic heating.

Figure 3-15. Close-out photo shows RCC panel 9 wing leading edge temperature measurement.

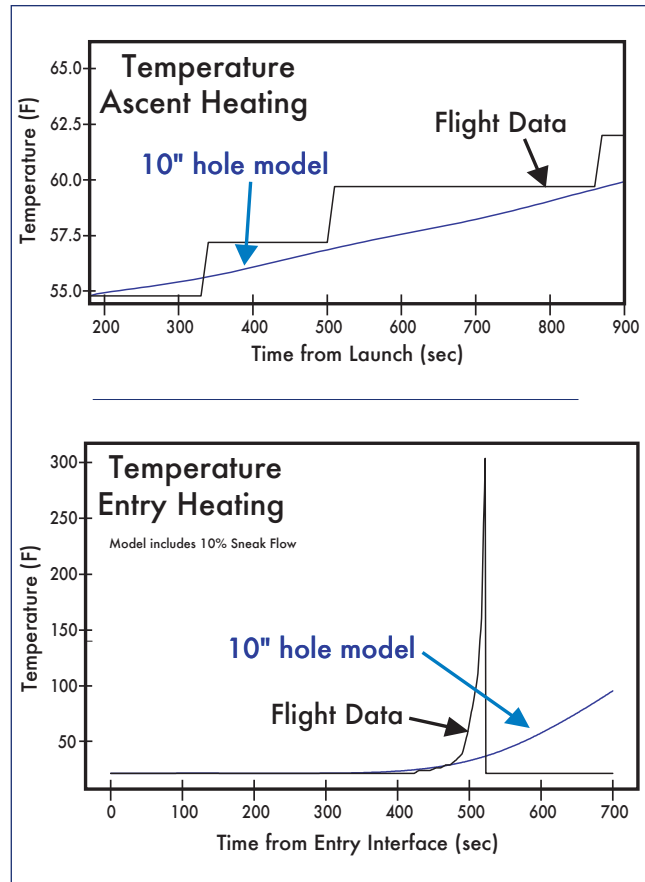
Figure 3-17. Correlation between simplified thermal math model and STS-107 ascent and entry flight data.

STS-107 had a 7.5 degree Fahrenheit rise that started very early during ascent (five to six minutes after launch). Although the data do not prove that the RCC was breached during ascent, the data are consistent with a possible flow path into the RCC cavity via damage in the RCC panels 6 through 8 area. A simplified thermal math model was constructed and verified with flight data from STS-5. The model was then correlated to the flight data from STS-107. Assuming the equivalent heating from a 10 inch diameter hole in RCC panel 8, this model nearly predicts both the ascent and entry temperature profiles for the wing leading edge spar temperature sensor. Figure 3-17 compares the model with

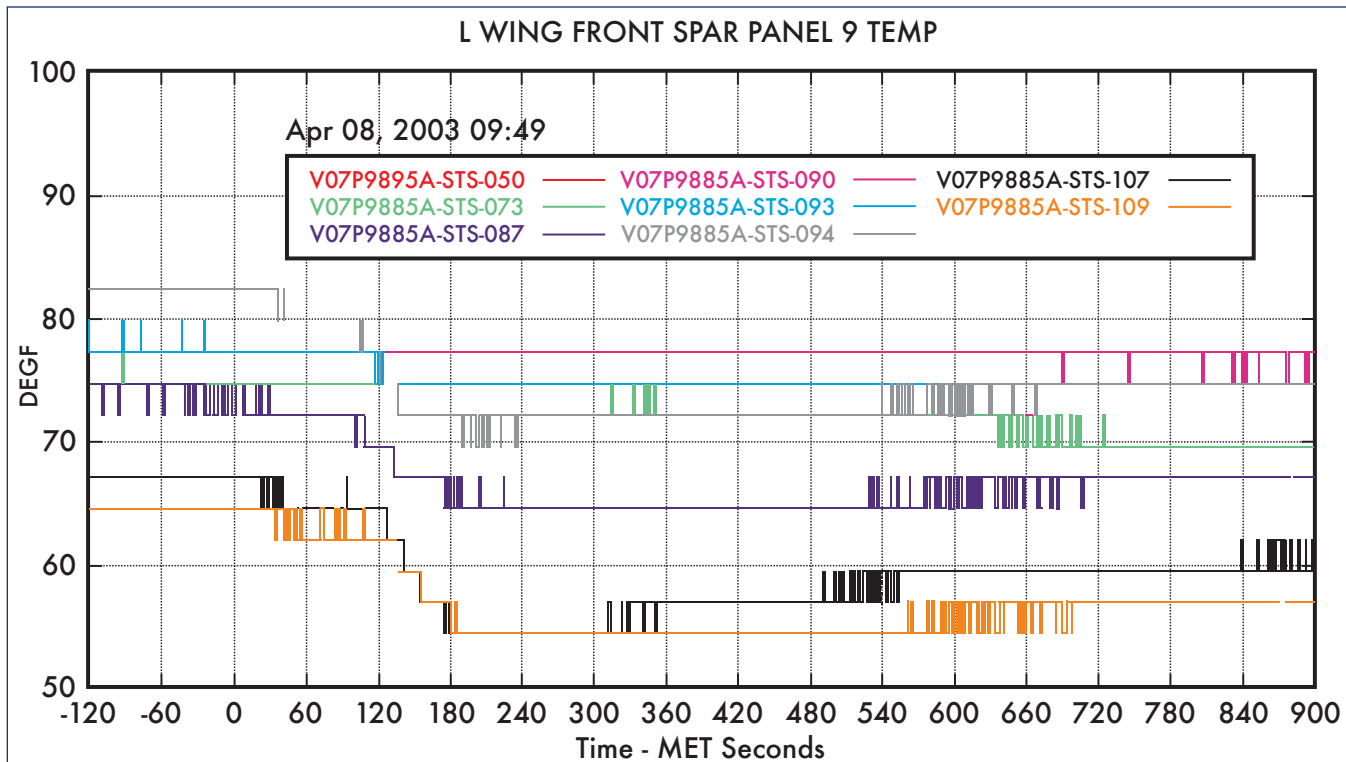
Figure 3-16. Three-bit rise (7.5 degrees F) on MADS wing leading edge spar temperature measurement (V09T9895A) during ascent.

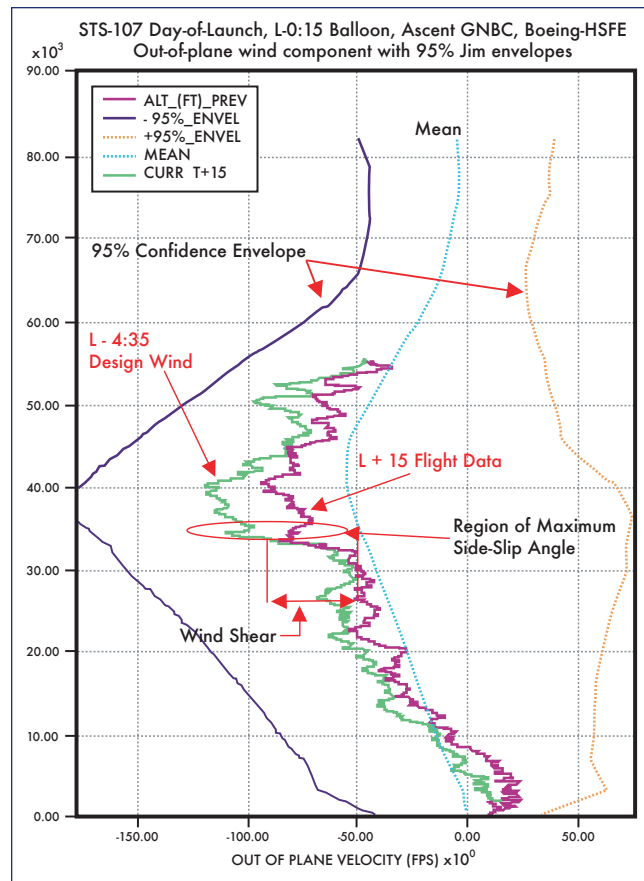
STS-107 experienced a wind shear during the period of maximum dynamic pressure starting at 57 seconds MET (Mach 1.27). The wind shear was due to a rapid change in the out-of-plane wind velocity of -37.7 feet per second over a 1200 foot altitude range starting at approximately 32,000 ft (as shown in Figure 3-21). Immediately after the vehicle flew through this altitude range, its side-slip angle began to increase in the negative direction, reaching a value of approximately -1.75 degrees at 60 seconds. This value of side-slip angle is a new flight experience value for MET 60 seconds (as shown in Figure 3-22). Post-flight data indicates that the new flight experience side slip event was not the result of the wind shear itself. Instead, it was the direct result of a difference in the L - 4:35 minutes balloon measurement, upon which orbiter guidance commands were updated on launch day, and the actual winds flown through by the orbiter during launch and ascent. Figure 3-21 highlights the difference in these two winds in this altitude region (a 25 foot per second increase in out-of-plane magnitude pre-launch compared to a 12 foot per second reduction in magnitude as experienced by the vehicle).

Several theories consider this wind shear event and the difference between the balloon data to be significant. A negative side-slip angle places the wind vector on the left side

Figure 3-21. Out-of-plane wind velocity.

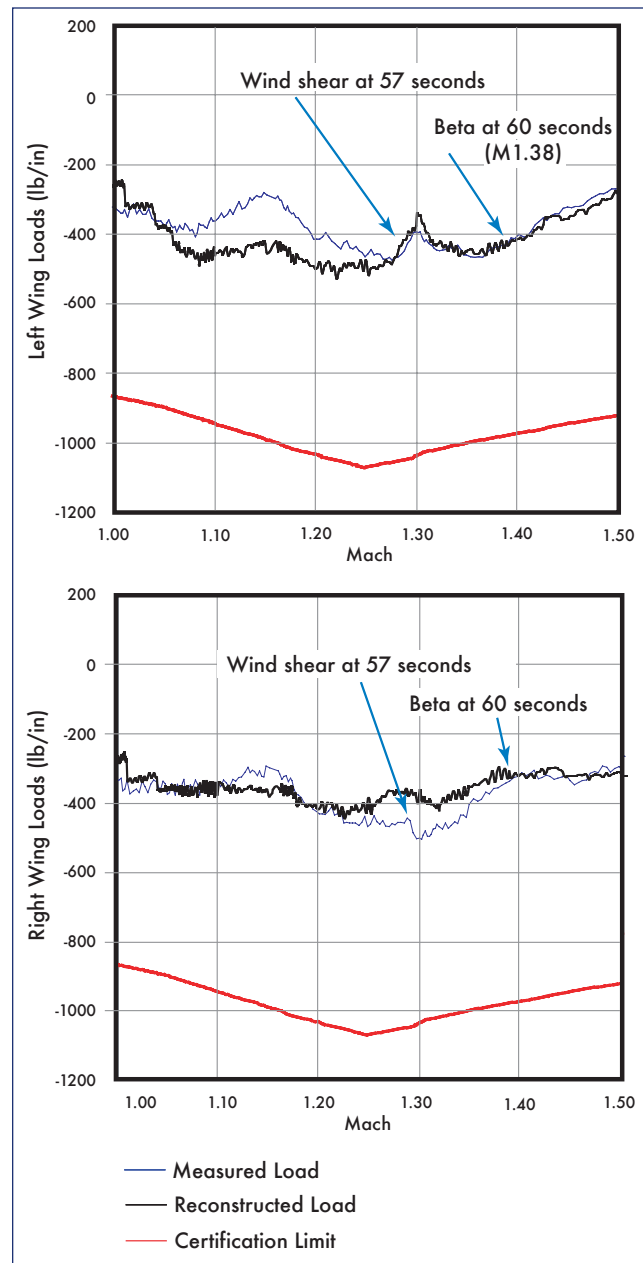
generate the loads on the orbiter wings during ascent. The assessment demonstrated that all orbiter wing loads were 50 to 60% of their design limit, or less, throughout the ascent. This includes the wind shear event at 57 seconds MET, and subsequent side-slip angle at 60 seconds MET (as shown in Figure 3-23).

Figure 3-23. Wing loads during wind shear and side-slip angle.

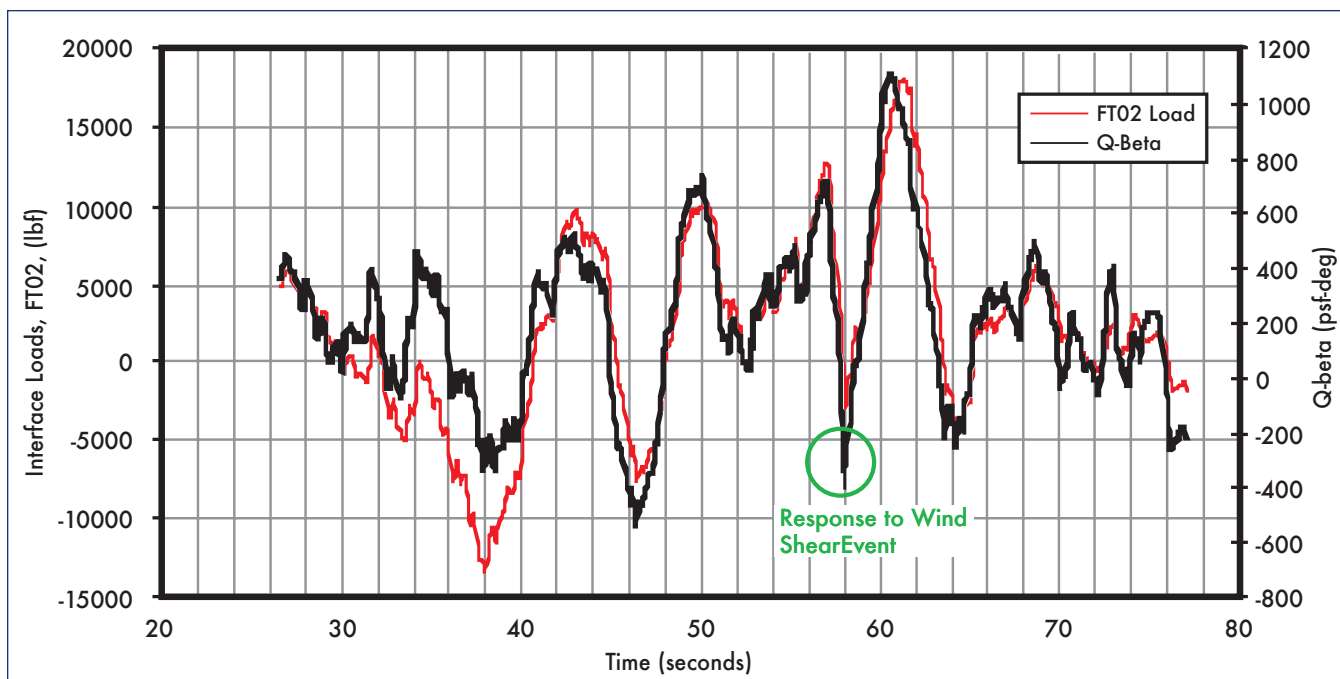
The ET/orbiter interface loads were generated using reconstructed trajectory parameters that included the effects of wind shear/crosswind, side-slip angle, and ET liquid oxygen (LOX) slosh. The loads analysis demonstrated that the ET forward attach loads were within certification requirements at all times. The wind shear event had only a small effect on the overall ET loads relative to the required limits (as shown in Figure 3-24), as did the ET liquid propellant slosh

Figure 3-24. ET interface loads at forward attachment during wind shear and side-slip angle. Q-beta is side-slip angle multiplied by the dynamic pressure and represents the side-slip angle contribution of the interface load.

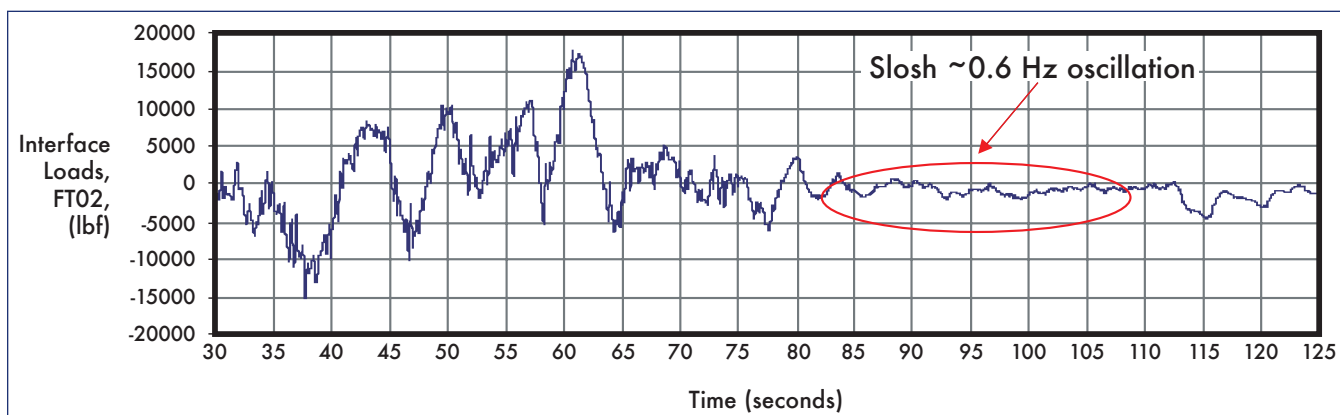
Figure 3-25. Slosh effect on ET interface loads.

(as shown in Figure 3-25). The resulting load from the wind shear event was of the same order magnitude as the roll maneuver and other first stage events prior to SRB separation.

The data from the ET LOX slosh study indicate that the flight control system operated as designed, and that more than adequate slosh phase stability margin existed. When the ET LOX slosh data is combined with the integrated vehicle loads analysis results (reference Figure 3-25), data indicate that the ET LOX slosh did not result in excessive vehicle loads at the orbiter/ET interface.

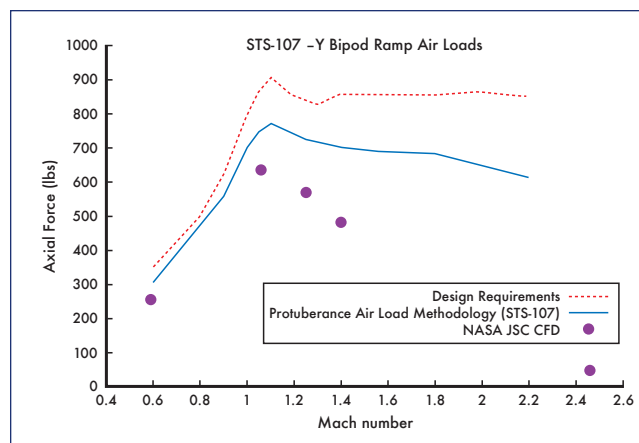
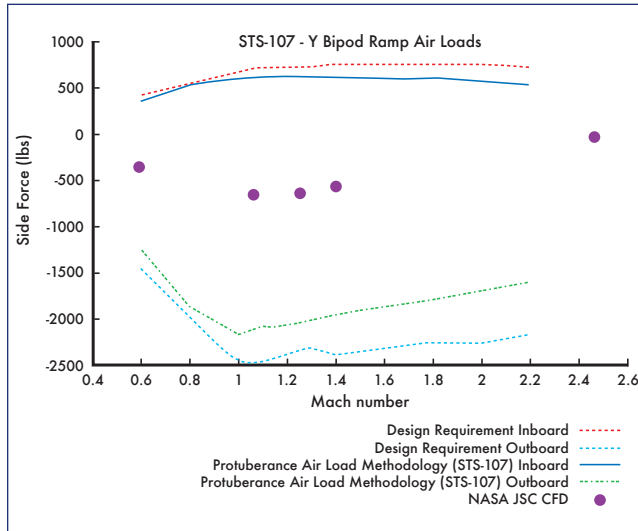
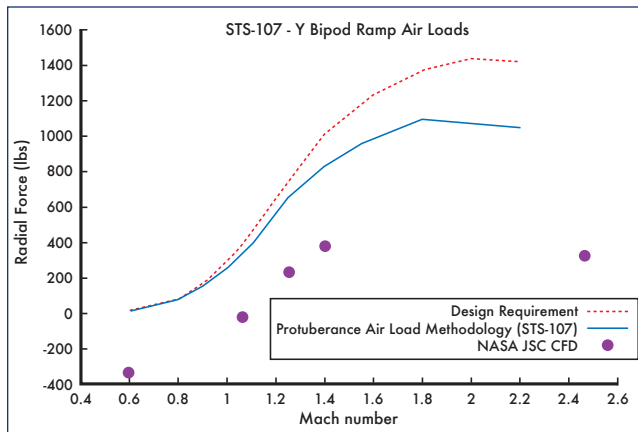
The external aerodynamic loads on the ET forward attach bipod were analyzed using a CFD simulation. The simulation produced axial, side-force, and radial loads as shown in Figure 3-26, Figure 3-27, and Figure 3-28, respectively. The CFD assessment of the bipod area indicated that the external air loads were below the design limit during the Hi-Q region and at the time of the bipod foam liberation.

Flexible body simulation results indicate that all vehicle elements and associated loads were within required limits. The reconstruction loads analyses indicate that the ascent environment-induced loads alone did not cause the ET bipod foam loss.

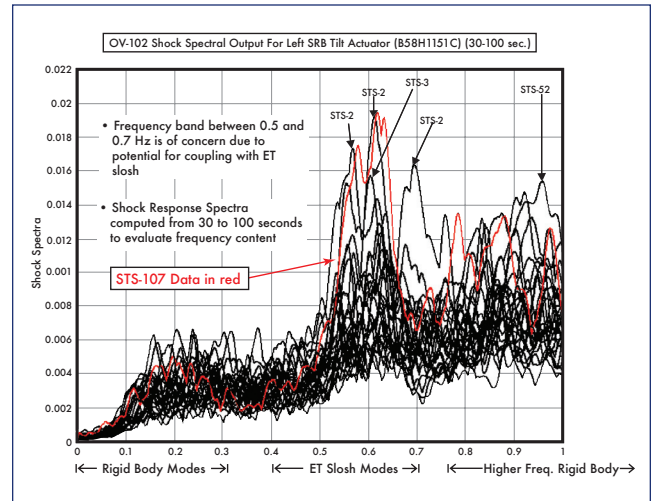
Figure 3-29. STS-107 SRB tilt actuators experienced more than typical 0.6 Hz content.

The STS-107 ascent data indicate a 0.6 Hz actuator oscillation frequency that peaks in amplitude at 55 seconds, and again at 77 seconds MET and continues through SRB separation. The peaks directly correlate to peaks in 0.6 Hz wind content. A 0.6 Hz oscillation in the Flight Control System output is of interest since it can couple with the ET Liquid Oxygen (LOX) slosh mode. Slosh refers to the repeated side-to-side movement of the center of gravity of the liquid oxidizer propellant in the external tank. The slosh mode frequency and amplitude cannot be measured directly through vehicle data. In order to determine if ET LOX slosh is present, a post-flight process of reviewing the vehicle SRB and SSME actuator frequency content must be conducted, as well as that of the launch wind. When this post-flight process was conducted for STS-107, it revealed that this flight experienced more than typical 0.6 Hz frequency content in the SRB tilt actuators with moderate content in the rock actuators. Figure 3-29 illustrates this point with the results of the SRB left tilt actuator frequency response as compared to previous *Columbia* flight history.

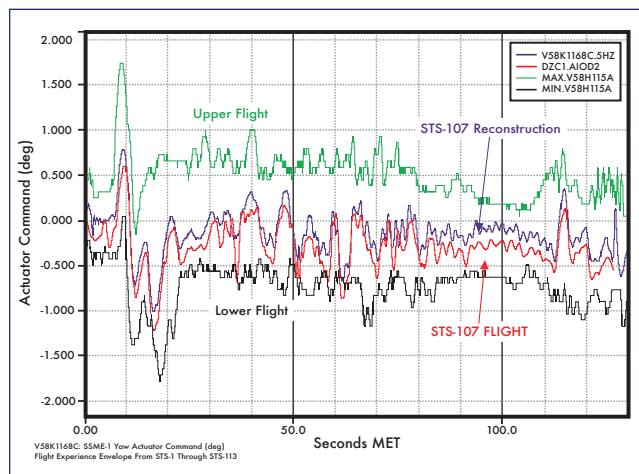
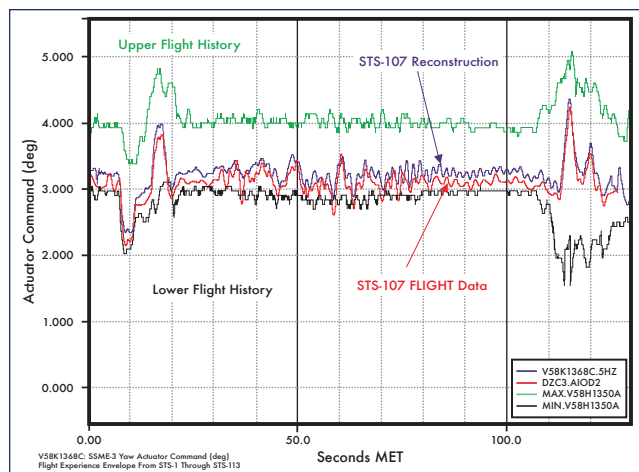
A review of the STS-107 ascent data identified two discrete points in time when the SRB and SSME nozzle positions exceeded the flight experience envelope for those respective times in the ascent profile. The first event occurred when the center and right SSME yaw deflections exceeded the previous flight experience envelope during the period of maximum dynamic pressure, as a result of the differences between predicted and actual flight wind conditions (as shown in Figure 3-31 and Figure 3-32).

Figure 3-31. Center SSME yaw position.

Figure 3-32. Right SSME yaw position.

The large offset in the Center and Right SSME yaw positions at 62 seconds MET was the reaction of the flight control system to the wind shear event and day-of-launch wind differences as compared to the DOLILU design. The nozzle motion was within the capability of the Shuttle flight control system, and the system operated as designed. As discussed in Section 3.5.1, the reconstruction loads analyses indicate that the ascent environment-induced loads alone did not cause the ET bipod foam loss.

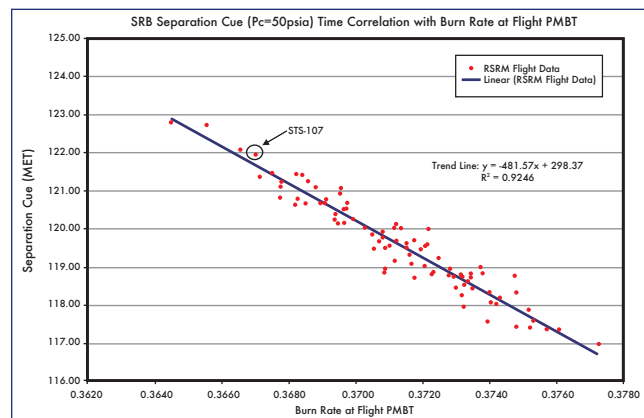
Figure 3-33. RSRM burn rate at propellant mean bulk temperature (PMBT).

The RSRM burn rate is a temperature dependent function, and is determined based on pre-flight tests of small samples of the actual motor propellant at a reference temperature. These values are then adjusted based on a Predicted Mean Bulk Temperature (PMBT) based on the actual weather conditions prior to launch day. For STS-107, the pre-flight predicted motor performance was very close to that determined by post flight reconstruction. A low RSRM burn rate does

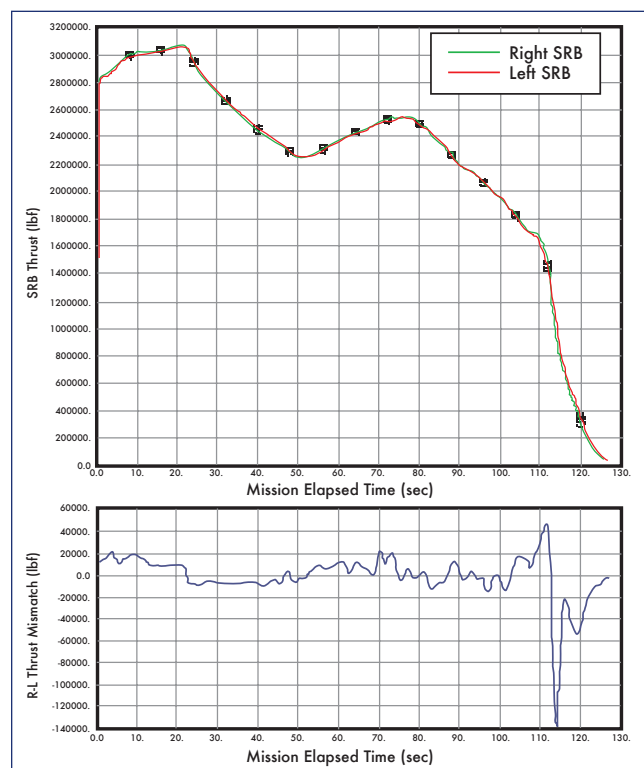
Figure 3-34. SRB thrust mismatch.

The SRB thrust mismatch observed during tail-off was well within the design margin of the flight control system, and similar occurrences have happened numerous times during previous flights.

The data indicate that the SRB thrust mismatch on STS-107 was a direct result of SRB burn rate differences between the left and right SRB. The thrust mismatch observed on STS-107 and the new flight experience nozzle positioning occurred after the foam shedding event. The SRB thrust mismatch occurred on the majority of flights in both families of flights, including those that did not shed foam.

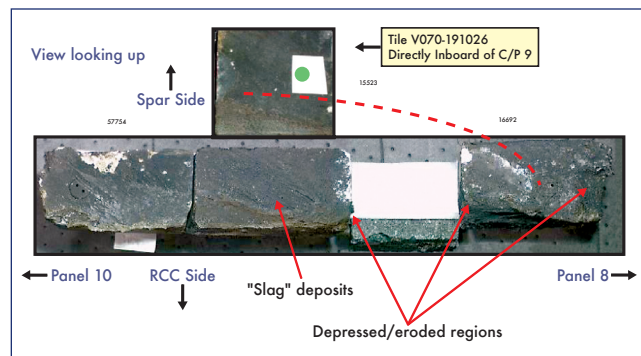
ure 5-4 and Figure 5-5 show an example of the rib erosion and the flow on the lower carrier panel 9.

Figure 5-5. Flow on the lower carrier panel 9 tiles.

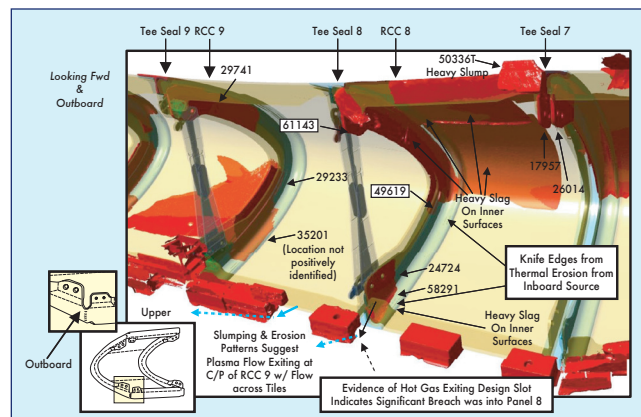
Figure 5-6 is a CAD drawing of the recovered debris showing overall slag deposition and erosion patterns. The drawing is a view from behind the RCC panels since this provides the best view of the erosion and slag deposition. Three full Tee seals can be seen in this drawing; the leftmost, Tee seal 9, divides panel 9 and 10; Tee seal 8 in the center divides panel 8 and 9; the rightmost, Tee seal 7, is the division between panel 7 and 8. The drawing shows the heavy slag deposition of the upper portion of panel 8 indicating that the probable breach area was the bottom of panel 8. The severely eroded RCC ribs are also visible near the RCC panel 8/9 Tee seal. The heavy slag on these inner surfaces indicate flow from the panel 8 direction toward panel 9. This is also consistent with the knife-edge erosion shown in Figure 5-4. The proposed flow direction leading to the erosion and slag deposition on the lower carrier panel 9 tiles can be seen in this view as well. The detailed flow, erosion, and deposition are best viewed in Figure 5-5. The last significant feature in Figure 5-6 is the heavy slumping that is observed on the upper carrier panel 8 tile (50336T) in the upper right portion of the drawing.

The data shown in Figure 5-6 is important when combined with the analysis of the slag deposition. The slag deposition on the upper RCC panel 8 was analyzed using sophisticated cross sectional optical and scanning electron microscopy, microprobe analysis, and x-ray diffraction to determine the content and layering of the slag deposition. This analysis indicated that the materials in this area were exposed to extremely high temperatures, since Cerachrome insulation was deposited first and its melting temperature is greater than 3200 degrees Fahrenheit. The analysis also showed no presence of Aluminum 286 in the slag indicating that the RCC attach fittings were not in the direct line of the breach and that the Inconel 718 spanner beam was one of the first internal items to be subjected to heating. Inconel slag was prevalent in much of the analyzed slag indicating melting of the spanner beam, foil, and associated insulation. Aluminum was found in the last deposited layer indicating the wing honeycomb spar was the last area to be subjected to hot gas flow.

Figure 5-6. CAD drawing of the recovered debris showing overall slag deposition and erosion patterns.

patterns, the breach was in an area that caused the flow to impact the spanner beam associated with Tee seal 8 and create the knife edge erosion shown in this area in Figure 5-6.

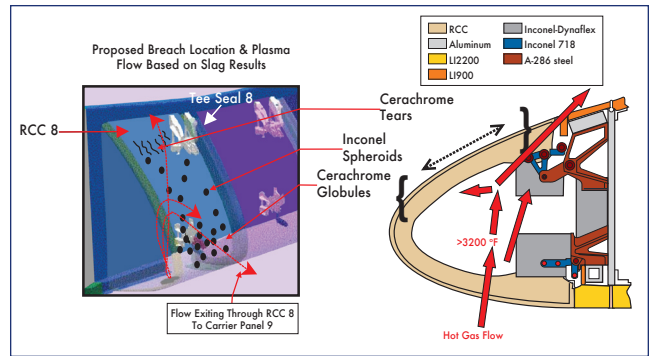
As time progressed, the Cerachrome and Inconel wing spar insulators were eroded, and eventually hot gas flow impinged on the wing leading edge, burning through the honeycomb spar. Figure 5-7 depicts the possible flow direction and deposition of various metals as determined by this analysis.

**Figure 5-7. Analysis results show possible flow direction and deposition of metals.**

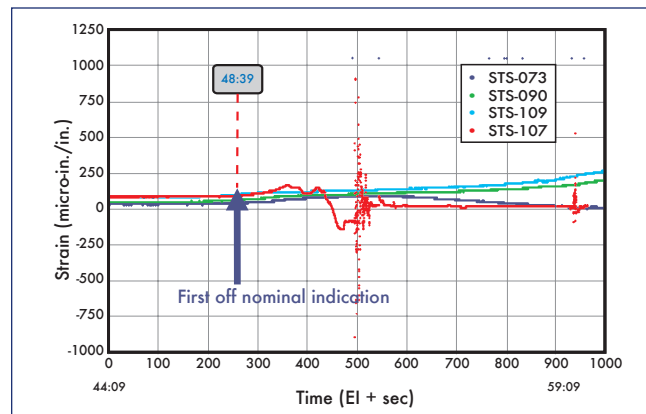
At approximately 8:48:39 EST (EI + 270 sec.), a left wing leading edge spar strain gauge began a small off-nominal increase. Figure 5-11 shows the STS-107 response of this

Figure 5-11. Left wing RCC panel 9 strain gauge is first measurement to indicate an off-nominal event. Note that EI was at 8:44:09 EST.

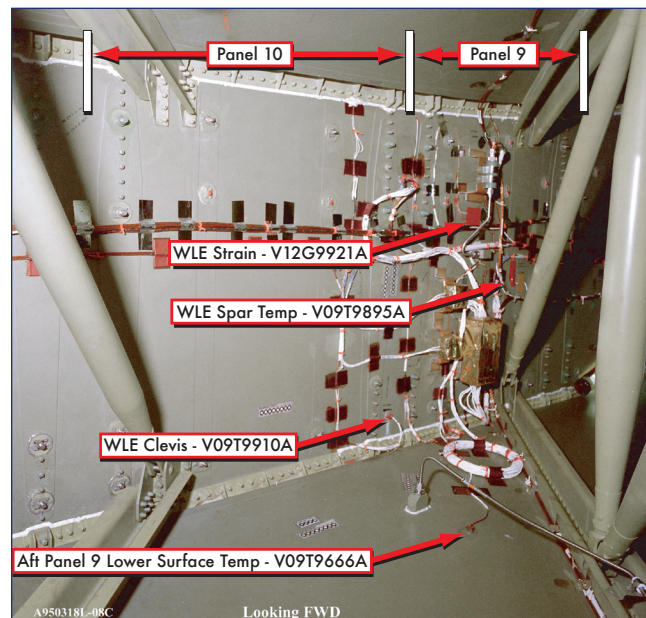
Figure 5-12. MADS sensors inside left wing.

strain measurement along with three other previous *Columbia* missions. Figure 5-12 shows the location of this sensor (WLE Strain V12G9921A) and others on the wing leading edge. The damage in lower RCC panel 8 is believed to be the cause of this strain increase. The breach allowed hot gas intrusion onto the panels 8 through 9 wing leading edge spar area leading to extreme heating and thermally induced strain. The strain increase grew over time and reached a maximum at approximately 8:50:09 EST (EI + 360 sec.). Thermal and structural analyses indicate that a breach would need to be within approximately 15 inches of the strain gauge to create the observed strain increase.

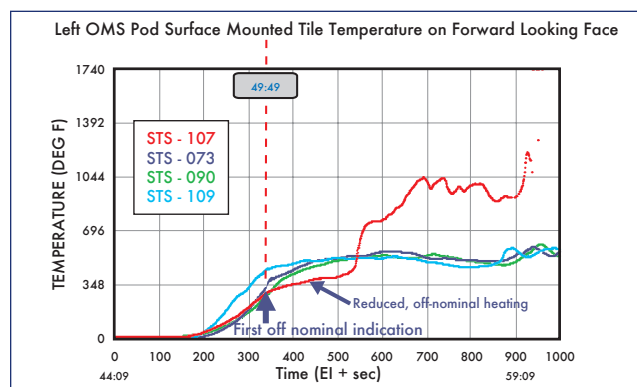
Figure 5-14. Typical off-nominal OMS pod thermocouple (V07T9220A).

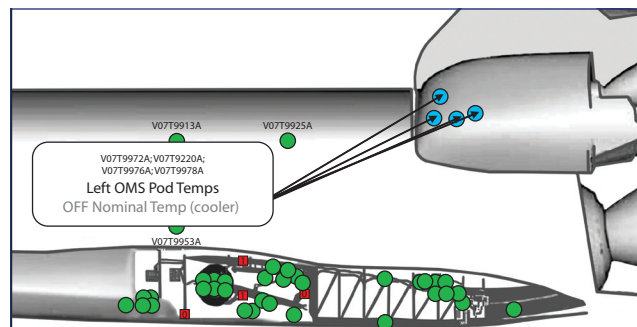
Figure 5-15. Location of OMS pod thermocouples off-nominal low.

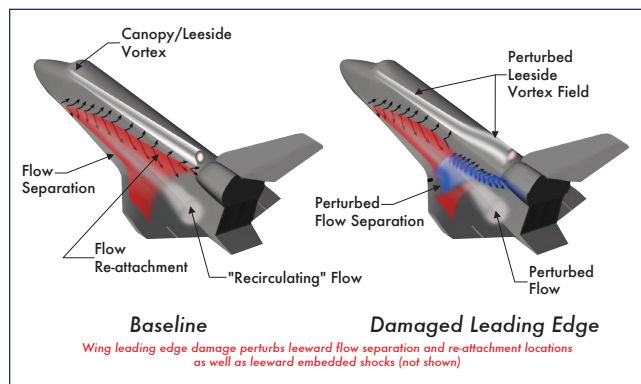
meets the orbiter fuselage to move from their normal positions, thus reducing the heating on the OMS pod. Figure 5-16 depicts the change in the upper wing surface vortices and the weak upper surface flow.

Figure 5-16. Postulated orbiter leeside flow field associated with wing leading edge damage.

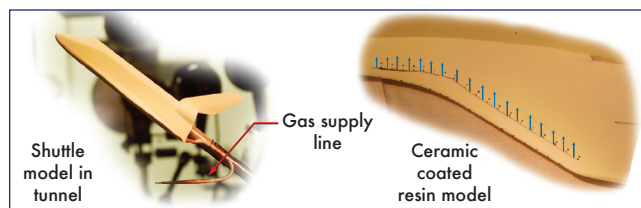
Figure 5-17. Orbiter wind tunnel model with vent gap along wing leading edge.

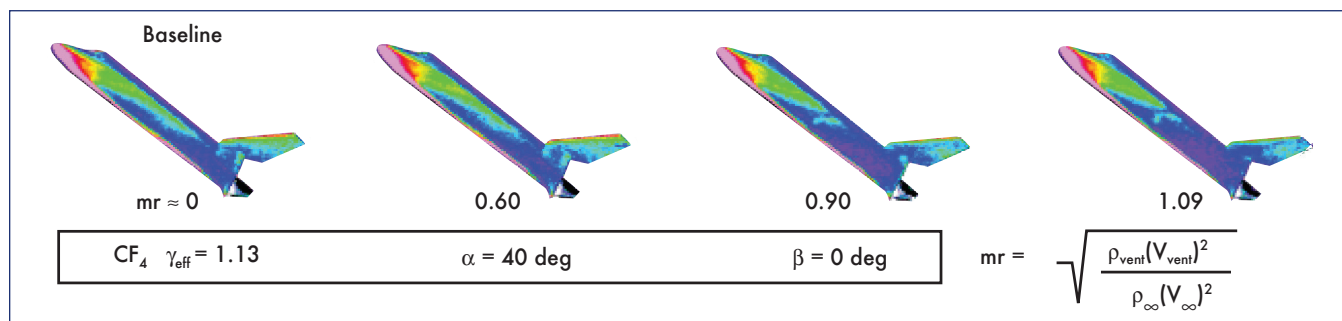
Figure 5-18. Wind tunnel model results for sensitivity of orbiter side fuselage and OMS pod heating patterns to mass addition along WLE leeside vent gap.

the RCC upper surface vent. Figure 5-18 shows the change in heating as the vent velocity is altered.

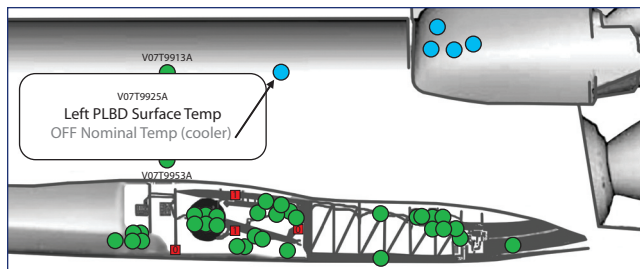
In the same timeframe, at 8:50:09 EST (EI + 360 sec.), a left payload bay fuselage MADS surface temperature measurement (Figure 5-19) showed an off-nominal temperature trend. This trend is a reduced rise rate when compared to other previous *Columbia* missions, as shown in Figure 5-20. The previously discussed theory of venting and or disturbed flow due to panel 8 damage, causing a shift in the vortices on the upper surface of the wing, is also believed to be the cause of this off-nominal behavior. The flow field and venting on the upper surface rate are constantly increasing since the mass flow rate into the RCC breach is increasing as the orbiter descends lower into the atmosphere.

Figure 5-19. Location of left sidewall temperature sensor.

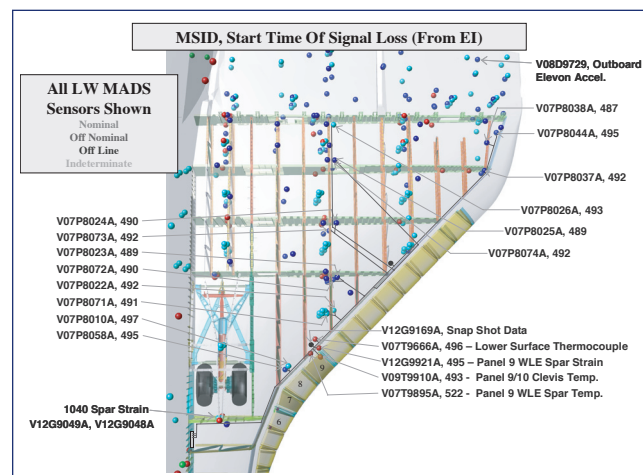
Figure 5-22. Left wing MADS sensors, including Measurement Stimulation Identification (MSID) number, and start time of loss of signal (EI + sec.).

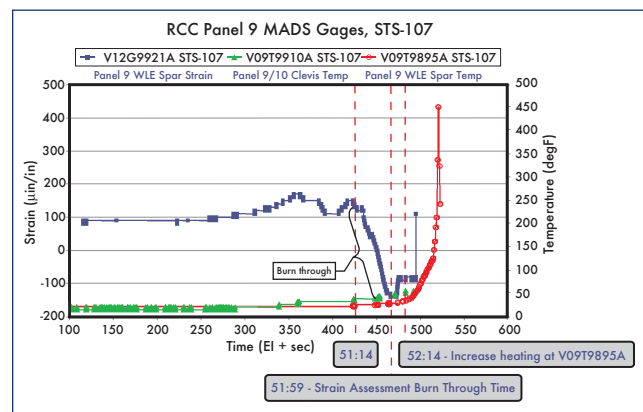
By 8:51:14 EST (EI + 425 sec.), the wing leading edge spar temperature began an early, off-nominal rise, shown in Figure 5-23. At the same time, the clevis temperature in the RCC panel 9/10 region continued to increase. The initial spar temperature rise was relatively slow and was caused by

Figure 5-23. RCC panel 9 MADS strain and temperature measurements, STS-107.

The first technique used the strain response, shown earlier in Figure 5-23. On this plot, the initial strain rise that began at about 8:49:09 EST (EI + 300 sec.) is due to thermal elastic strain. It appears that the spar structural softening occurs at approximately 8:50:09 EST (EI + 360 sec.), followed by loss of the structural integrity, or breach, at approximately 8:51:14 EST (EI + 425 sec.). This appears to be completed by approximately 8:52:00 EST (EI + 471 sec.). A detailed structural model that attempted to reproduce the thermal strain response observed during this timeframe confirmed this timing. This analysis determined that the location of the spar breach must be within about 15 inches of the spar strain measurement. This would locate the spar breach near the intersection of panel 8/9, as shown in Figure 5-29. The flow through the RCC breach maintained some directionality although it was influenced by the shape of the hole, remaining RCC structure, attach hardware, and leading edge insulators. Overall, this strain response is consistent with an RCC breach in the lower part of panel 8 as previously discussed in Section 5.3. Although it is difficult to pinpoint a precise location of the RCC breach, this analysis supports the argument that the breach was closer to the panel 8/9 intersection and Tee seal 8.

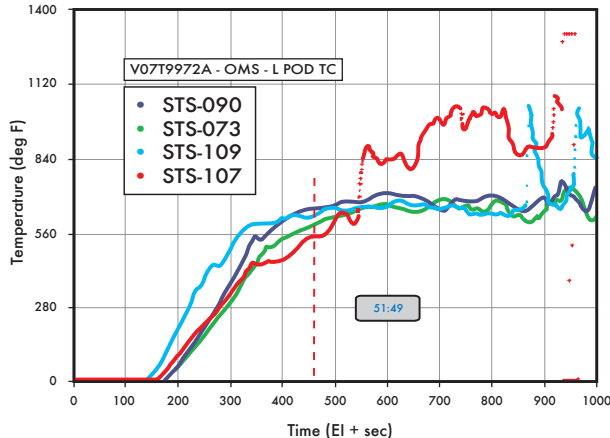
At 8:51:49 EST (EI + 460 sec.), one of the left OMS pod measurements (V07T9972A) began to show an increased temperature rise, indicating that the upper surface flow has changed again. This is shown in Figure 5-24 along with this measurement on other *Columbia* missions. It is evident that the measurement rises to a higher temperature and at a faster rate than has been observed on previous missions within the next few minutes. Figure 5-25 shows other left OMS pod and fuselage temperature measurements that exhibit an off-nominal rise later in time. The sensor locations on the left side of the orbiter are also shown in Figure 5-25.

Figure 5-24. Off-nominal low OMS pod thermocouple (V07T9972A).

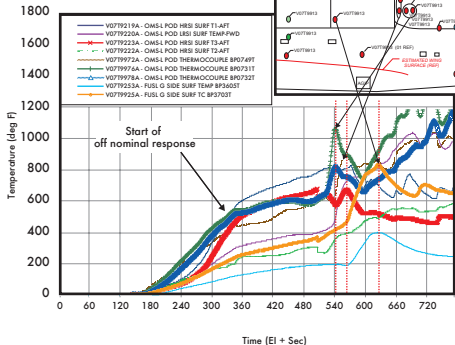
Figure 5-25. Left side fuselage/OMS pod off-nominal responses indicate increased heating.

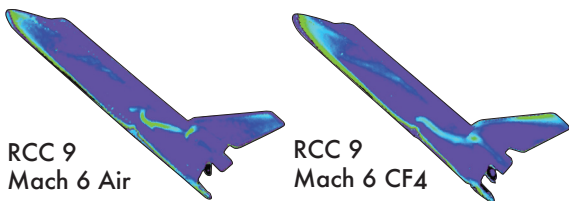
*Figure 5-26. Wind tunnel test results for RCC panel 9 missing and resulting in increased heating to OMS pod.*

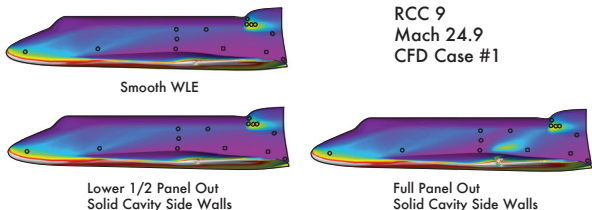
Figure 5-27. CFD results for no damage, partial damage, and full damage to RCC panel 9 show increased heating on side fuselage and OMS pod.

These off-nominal temperature rises were caused by a change in the flow field along the upper portion of the left wing as the wing leading edge (WLE) and wing spar damage progressed. The mechanism was a shift in the vortices due to venting on the upper portion of the wing and is similar to the previous discussions on lower than expected OMS pod temperatures. Wind tunnel testing and CFD analysis confirmed that WLE damage on RCC panels 8 and 9 could cause increased heating to the OMS pod due to disturbed upper surface flow or flow impingement caused by re-directed flow from the lower surface. Additionally, the molten Inconel 718 and A-286 spray onto this area are indications that this flow is the cause of these temperature rises. Figure 5-26 (from wind tunnel test results) is a representative example of increased heating on the left fuselage and OMS pod due to RCC panel 9 damage from wind tunnel test results. Figure 5-27 shows a similar picture of the left side as determined by CFD analysis. Note that neither the wind tunnel testing nor the CFD analysis accounts for increased heating that is likely due to molten metal contacting the OMS pod.

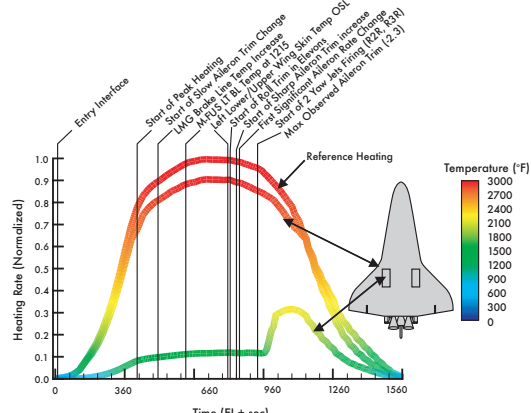
The next significant event was a breach through the left wing leading edge spar leading to many wire measurement failures and eventual deformation of the left wing. As discussed in Section 5.4.2, by approximately 8:52:00 EST (EI + 471 seconds), strain and temperature measurements indicated that hot gas had begun to weaken the wing spar. Figure 5-28 shows that the orbiter has entered the peak-heating region during this timeframe and would remain there for many of the ensuing events that will be discussed later.

Figure 5-28. STS-107 entry heating rate profile.

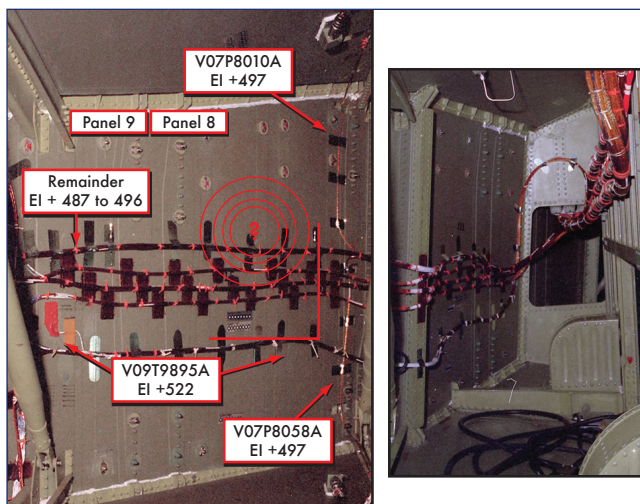
Figure 5-29. Cable routing on wing leading edge and wheel well wall.

The final technique used was an examination of the wire failures on the wing leading edge spar. These wire runs are shown in Figure 5-29. The first measurement loss was a MADS upper left wing pressure measurement, which failed at approximately 8:52:16 EST (EI + 487 sec.). This measurement is contained in the upper wire bundle in the left photo in Figure 5-29. The combination of these three separate and distinct analyses results in a range of wing spar breach times as early as 8:51:14 EST and as late at 8:52:16 EST (EI + 425 to 487 sec.).

Immediately after the breach, hot gas inside the wing began to heat the remaining wire bundles that contained real-time telemetry and the recorded MADS measurements. Figure 5-29 shows an inside-the-wing view of the approximate breach location based on this wire failure analysis. The view on the left is of the panel 8/9 spar location. This area is not visible in the right photo, which contains the transition spar and a view of the three wire bundles along the outside of the wheel well wall. Figure 5-31 shows the overall spar breach location with respect to the rest of the wheel well. The distance from the spar to the wheel well wall in this area is approximately 56 inches, as shown in Figure 5-32. Figure

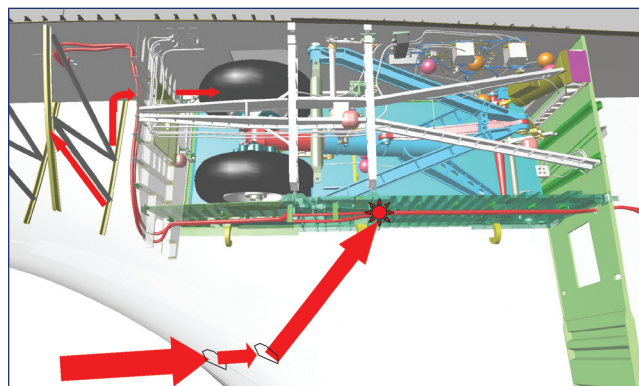
Figure 5-31. Hot gas begins to fill left wing.

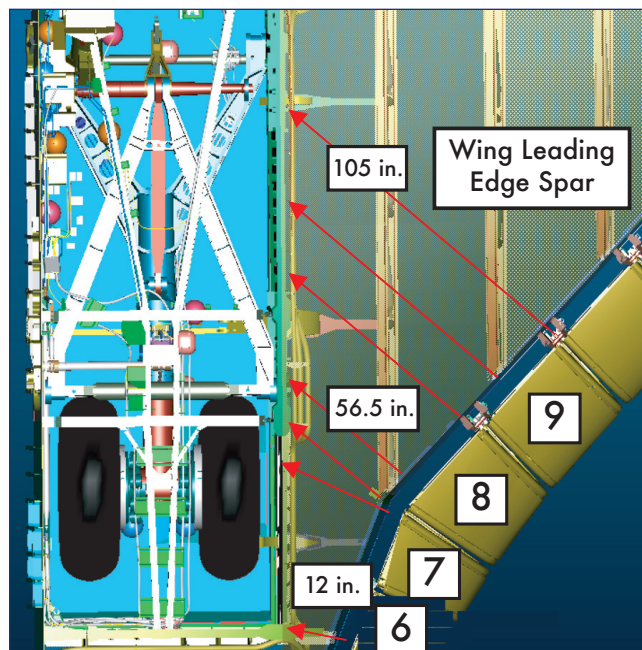
Figure 5-32. Columbia LH wing and wheel well geometry.

wheel well spar. The fact that these measurements are available until loss of data are important indicators that the RCC breach could not be forward on the panel 6 area since these measurements would have been lost as well (see Figure 5-32). These measurements also record key changes in strain that help indicate some of the changes that the left wing underwent as the remainder of the entry events unfolded.

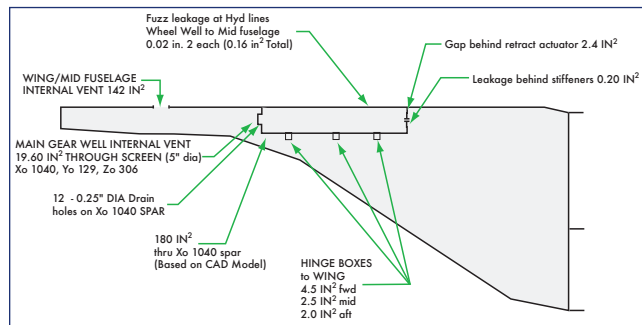
5-33 shows a sketch of the venting of the left wing into the payload bay, driving the direction of the internal flow depicted in Figure 5-31. Note the 142 square inch vent into the midbody fuselage located forward of the wheel well.

Figure 5-33. Columbia LH wing and wheel well vent model (wheel well leak paths based on Atlantis test comparison).

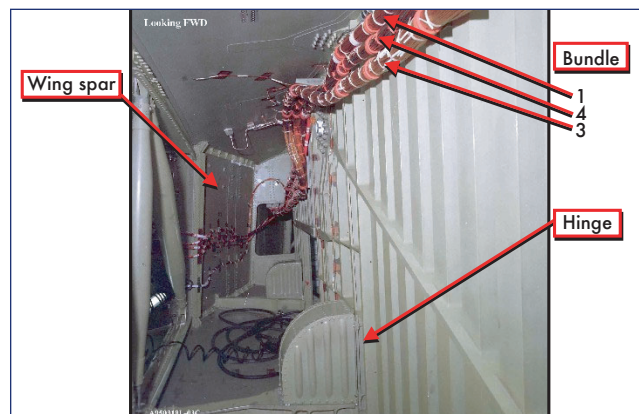
Figure 5-35. View of cables running along outside of wheel wall cavity bulkhead.

Four additional measurements failed after 8:54:16 EST (EI + 605 sec.) with the last starting to fail at 8:56:24 EST (EI + 735 sec.). This last measurement failure took over a minute to fail completely. Figure 5-34 and Figure 5-35 show the measurement loss timing and the wire bundle runs along the wheel well. Although almost all measurements internal to the wing failed, two strain measurements on the 1040 spar (forward of the wheel well) were unaffected and produced data until loss of all MADS data at 9:00:13 EST (EI + 964 sec.). Figure 5-36 shows the location of the sensors on the forward

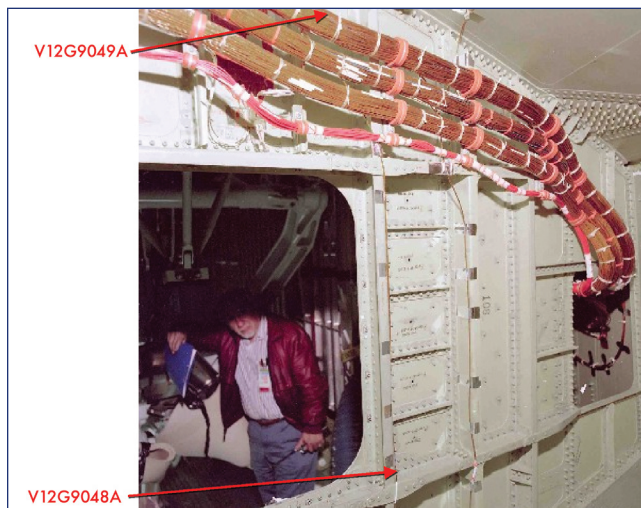
Figure 5-36. Strain measurements on 1040 spar.
