# Volume II

## Appendix D.7

### Working Scenario

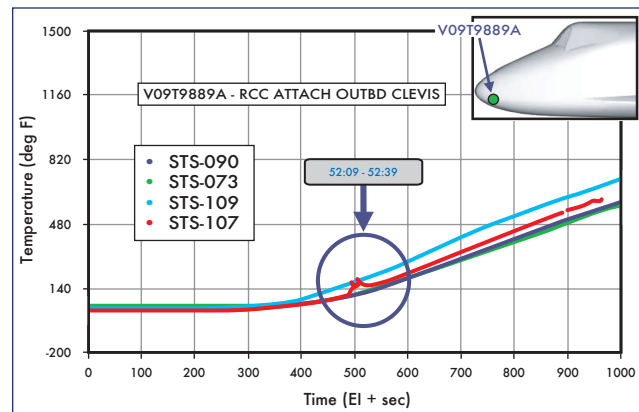
Coincident with the spar breach at approximately 8:52:09 EST (EI + 480 sec.), the nose cap RCC attach clevis temperature had an off-nominal change in rise rate when compared to previous missions. This rise rate was abnormal for approximately 30 seconds and ended at 8:52:39 EST (EI + 510 sec.). The exact cause of this abnormal temperature rise is not known, but the timing is coincident with the breach of the wing leading edge spar. An explanation is that the abnor-

mal rise is an instrumentation anomaly caused by multiple wire failures in this timeframe. This measurement response is shown in Figure 5-37 along with the same measurement for several other *Columbia* missions. This figure also shows the location of this internal nose cap measurement on the very forward portion of the left fuselage.

Figure 5-37. Off-nominal temperature rise rate in nose cap RCC attach clevis.

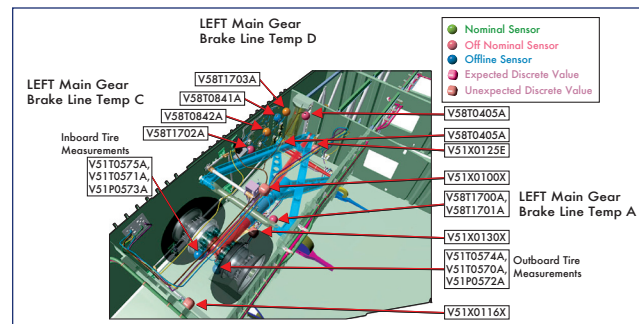
Figure 5-38. Location of sensors in the LH wing wheel well.

nominal. The first indication of any anomalous Operational Instrumentation (OI) was a small increase in the left main gear brake line temperature D measurement at this time (see Figure 5-38). Within one second of this time, there is a lower 1040 spar (forward wall of the wheel well) strain measurement that shows an off-nominal increase in strain (see Figure 5-39). These are both indications that the breach in the wing leading edge spar had allowed hot gas to reach the wheel well area, most likely through vent paths around the hinge covers, which allowed hot gas into the wheel well cavity.

At approximately 8:52:25 EST (EI + 496 sec.), the left outboard elevon wideband accelerometer showed an unusual 2 g peak-to-peak acceleration (see Figure 5-40). This is consistent with the timing of the many wire failures within the left wing and the timeframe when the spar breach occurs. Additionally, there are two unexplained communication dropouts in this same timeframe. Another 3 g peak-to-peak acceleration anomaly was observed at 8:52:31 EST (EI + 502 sec.). Additional temperature measurements (left main gear brake line temp A and C) in the wheel well area (see Figure 5-38) began an off-nominal rise at 8:52:41 EST (EI + 512 sec.).

At the same time as the stress was relieved on the lower 1040 spar, two left main gear outboard tire pressures began trending toward an off-scale low reading. This was preceded by a slight upward trend at 8:57:19 EST (EI + 790 sec.) for both pressure measurements. This is an indication of extreme heating of both the left outboard tire and the surrounding instrumentation. The tire has significant thermal mass and substantial heating would be required to produce the slight temperature rise. By 8:58:56 EST (EI + 887 sec.), all left main gear inboard and outboard tire pressure and wheel temperature measurements were lost indicating a rapid progression of damage or wire burning inside of the wheel well. Figure 5-38 shows the location of these pressure sensors.

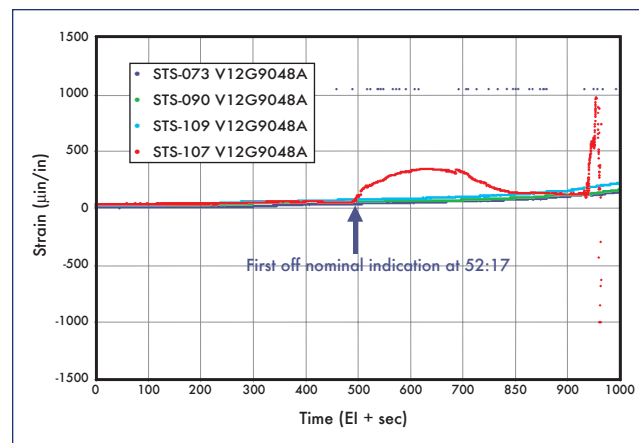
Figure 5-39. Strain rise in lower 1040 spar cap.

At 8:58:32 EST (EI + 863 sec.), there was a change in stress measured on the left wing 1040 spar (main landing gear forward wall spar), as indicated by strain gauge measurements that began trending up at 8:52:18 EST (EI + 489 sec.). At 8:58:32 EST (EI + 863 sec.) the lower cap strain (near the bottom of the 1040 spar) essentially returned to a normal measurement when compared to previous flights (see previ-

ous Figure 5-39). The upper strain measurement continued to increase during this timeframe indicating that the heating was different on the upper and lower portions of the wheel well and 1040 spar. Although the response of the 1040 spar strain is not completely understood, structural analysis indicates that the strain response can be completely explained by thermal stresses caused by severe heating of the wheel well wall and internal wing components.

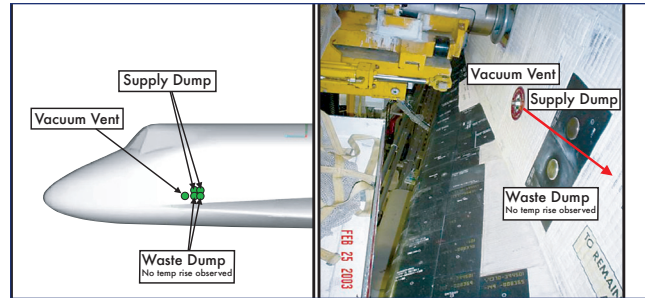
Figure 5-41. Location of supply dump and vacuum vent nozzles.

The elevon response event was followed by a change in the rise rate for two supply nozzle temperatures and the vacuum vent nozzle temperatures at 8:52:32 EST (EI + 503 sec.). The off-nominal rise rate occurred for approximately 15 seconds for the supply nozzle temperatures and 23 seconds for the vacuum vent temperatures. The location of these nozzles on the left side of the fuselage is shown in Figure 5-41, and the arrow indicates that they could have been located along a line of disturbed flow. The short, abnormal rise rate is unexplained, has not been observed on any previous Shuttle missions, and may not be associated with the upper wing disturbed flow caused by the leading edge damage. Unlike the RCC nose cap clevis temperature, the instrumentation appears to have been valid for both nozzles. Plots of this off-nominal temperature rise for one of the supply nozzle temperatures and the vacuum vent nozzle are shown in Figure 5-42.

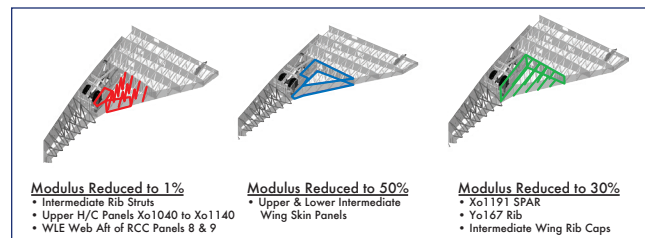
It is difficult to postulate the exact wing deformation that occurred. One case is localized leading edge damage, resulting in global wing deformation. Local deformation was relatively small, less than 1.0 inch in the damage area with a 0.25-inch global increase in wing tip deflection. Delta rolling and yawing moments were calculated for this case, and they were very small, approximately +0.0001 for roll and -0.0001 for yaw. Another case looked at deformation resulting from the loss of three internal ribs. Again, the local deformation

Figure 5-45. Modeling results show potential area of damage and that significant deformation of the intermediate wing area and/or a recession in the lower surface are possible.

was small (approximately 5 inches) and the resulting aerodynamic moments were small. These delta moments are in the correct direction for change in the aerodynamic moments, but are not nearly large enough in magnitude when compared to the flight derived moments for the time after the roll moment trend reversal. To achieve the aerodynamic response observed in the flight data, more significant damage to the wing would have been required.

Based on the structural analysis, it appears feasible that a wing recession occurred and resulted in the large positive slope in the delta rolling moment. The recession was caused by severe prolonged heating internal to the left wing that melted many of the support struts. Once the struts were lost, the wing skin lost structural support, a concave cavity developed, and some lower surface tiles may have been lost.

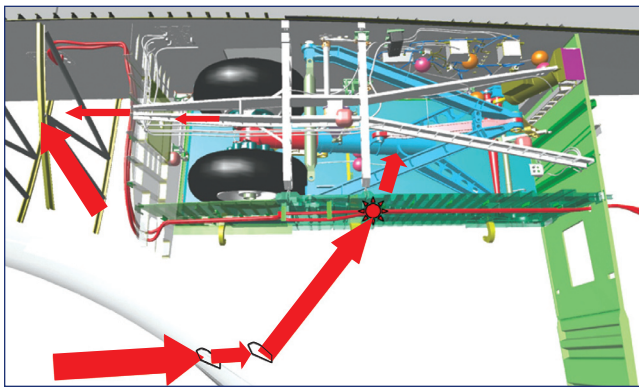
Figure 5-47. Hot gas breaches the wheel well.

Immediately after the wheel well wall was breached, a hot gas plume began to flow on to the left main gear strut (depicted in Figure 5-47), leading to excessive strut erosion. A wheel well wall breach in this area is consistent with the erosion pattern observed on the recovered left main gear strut. Even after damage had significantly progressed into the wheel well, the orbiter initiated the first roll reversal at 8:56:30 EST (EI+741 sec.). The maneuver was completed by 8:56:55 EST (EI+766 sec.), and the vehicle was in a normal left bank. The guid-

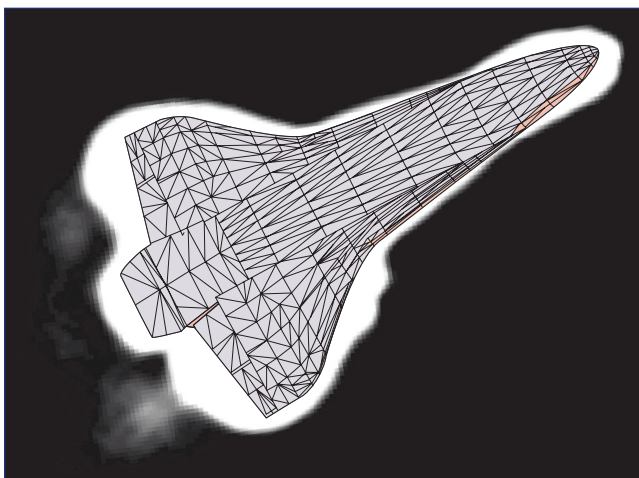
Figure 5-48. Kirtland photo with superimposed Orbiter outline.

Imaged at 8:57:14 EST (EI + 785 sec.), the Kirtland photo could indicate a flow disturbance on the leading edge of the left wing and/or flow leaving the leading edge of the left wing (see Figure 5-48). It also appears to show a disturbed flow leaving the trailing edge of the left wing. Other images, not shown here, also show disturbed flow on the upper side of the left wing, indicating that the damage and venting through the upper RCC vent was deflecting the flow upward. The Kirtland photo is a digital still image taken by off-duty employees of the Starfire Optical Range at Kirtland Air Force Base, New Mexico, during the STS-107 entry using a 3.5 inch telescope through a computer controlled 1 meter rotating mirror.

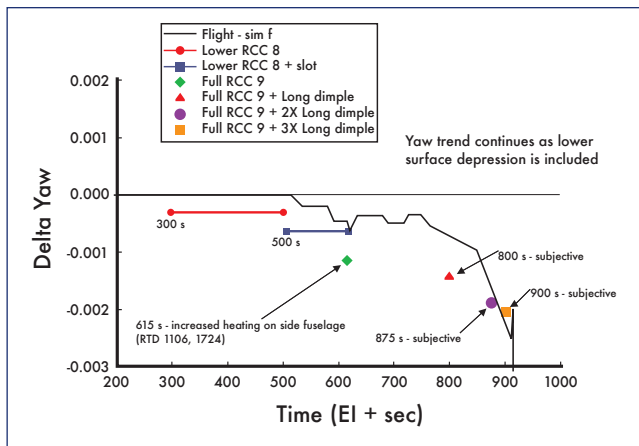
Figure 5-51. Wind tunnel configurations that match delta yaw moment data.

Figures 5-50 through 5-52 show the flight derived delta roll, yaw, and pitch aerodynamic moments, respectively, along with the tested damaged configuration results that are consistent with the flight data. The intent of the remainder of this

the wing leading edge and flow through a slot onto the upper carrier panel is consistent with the first observed aerodynamic response, which occurs at 8:52:29 EST (EI + 500 sec.). This can be observed in Figure 5-50 and Figure 5-51 as a slow negative trend in delta roll and yaw. Figure 5-55 shows the wind tunnel test results for three different cases: missing lower RCC panel 8, missing panel 8 combined with a 4 inch diameter hole in the upper carrier panel 8, and missing RCC panel 8 with a slot through the upper carrier panel. The slot was shown to produce the increased delta yaw observed during flight as well as the upper surface flow disturbances on the OMS pod and left side fuselage, which were also observed during flight by abnormal temperature rise rates.

Initially, the recessed area would have been relatively small; however, it would gradually grow over time to cause the delta roll moment to increase. By 8:57:29 EST (EI + 800 sec.) wind tunnel testing showed that the depression has to be on the order of 20 feet long, two feet wide, and 5.3 inches deep along with panel 9 missing in order to duplicate the delta roll coefficient shown in Figure 5-50. This configuration provides a delta yaw moment that is slightly larger than was observed, but is consistent with a decreasing negative delta yaw moment observed in this timeframe (Figure 5-51).

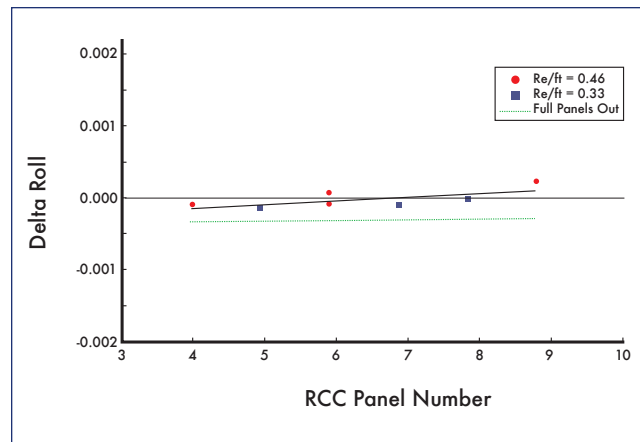
Figure 5-53. Delta roll for lower half and full panel RCC panel missing.

As discussed previously, the reconstructed aerodynamic moments showed little to no change due to damage through 8:52:29 EST (EI + 500 sec.). Based on the forensics data discussed in Section 5.3, the most likely region of initial damage was in the lower part of RCC panel 8. Wind tunnel testing in the Langley Research Center (LaRC) CF4 tunnel indicated that a missing bottom part of RCC panel 8 (from the apex to the lower carrier panel) matches the initial aerodynamic increments, which show a minimal effect on the overall vehicle aerodynamics. In fact, even a full missing panel 8 produces only a small change to the roll and yaw aero moments. Figure 5-53 and Figure 5-54 show the results of this LaRC evaluation.

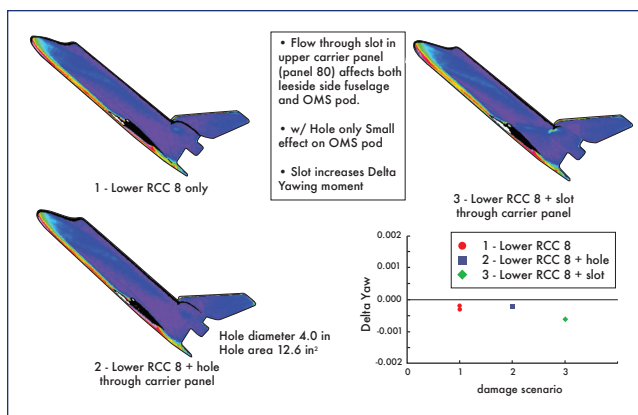
Figure 5-55. Wind tunnel testing results for missing lower carrier panel 8 and a slot and hole through wing.

It is possible that a hole through the upper wing developed in the 8:54:11 EST (EI + 600 sec.) to 8:54:31 EST (EI + 630 sec.) timeframe. This is consistent with a lull in the measurement failure rate in the wire bundle along the wheel well that was discussed earlier in Section 5.4.3. Wind tunnel testing and CFD analysis have shown that sizable holes through the wing have little to no effect on the aerodynamics and heating on the left side of the fuselage and OMS pod. A representative sample of this work is shown in Figure 5-55 as damage scenario number 2.

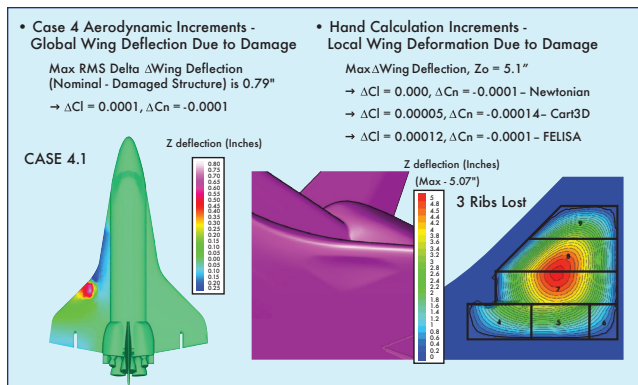
Figure 5-56. CFD analysis of wing deformation.

The next significant aerodynamic event occurred at 8:54:11 EST (EI + 602 sec.) when a dramatic reversal of the aero rolling moment trend occurs. By this time hot gas and an internal plume environment had severely degraded the structural integrity of some of the intermediate wing support structure leading to wing deformation. Three different configurations were tested to validate the theory of wing deformation. The first involved global wing deflection of up to 0.79 inches due to damage and is depicted in Figure 5-56. CFD analysis of this configuration showed extremely small aero moment response for yaw and roll that does not match the flight derived data. More substantial local wing skin deformation with a maximum deflection of 5.1 inches due to three ribs missing along with other internal wing damage was examined using CFD tools. Again, these results produced only small aerodynamic moment changes, which did not match the flight-derived data.

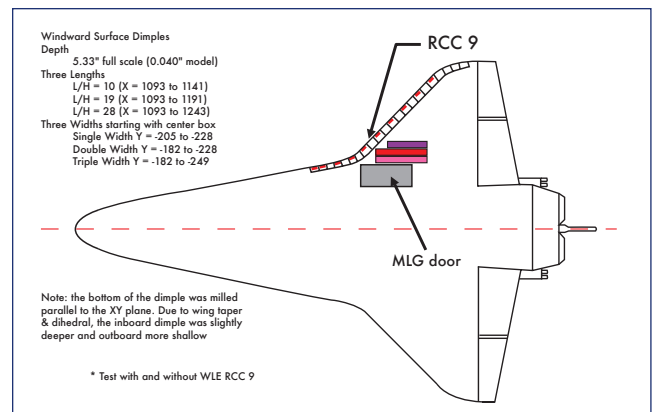
Figure 5-57. LaRC wind tunnel testing of lower surface depressions.

The third and final configuration that was tested was a depression in the lower surface of the wing caused by the significant structural damage caused by the hot gas plume environment internal to the wing. A previous section (5.4.5) discussed the internal structural damage that was most probable in this timeframe. LaRC wind tunnel testing and CFD analysis were performed for several different configurations of lower surface recessions shown in Figure 5-57. The data shows that it is feasible for a recession to cause

the change in the rolling moment sign when combined with some portion of RCC panel 9 missing at 8:54:11 EST (EI + 602 sec.).

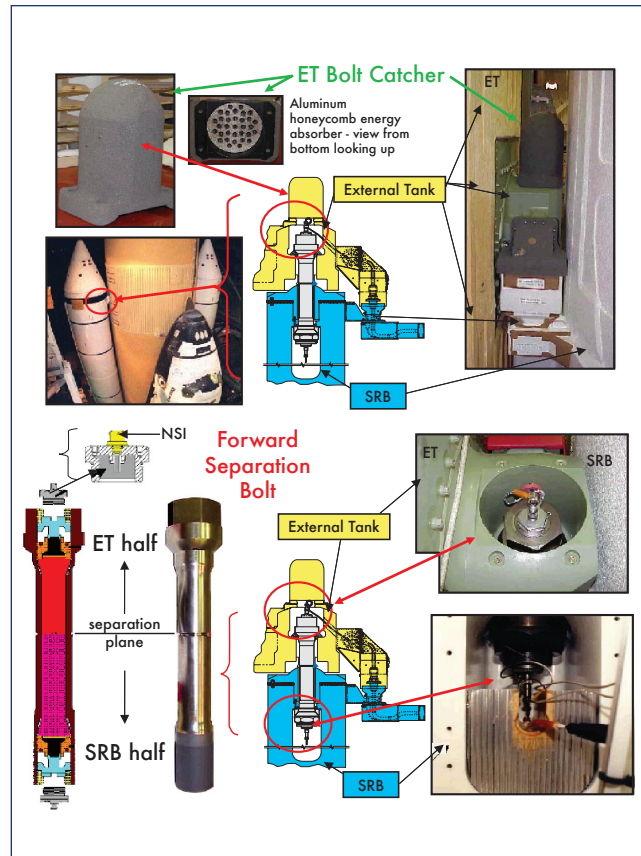
Figure 7-1. Details of SRB/ET forward separation bolt catcher assembly.

Four blocks on the STS-107 SRB fault tree remain open pending completion of forward bolt catcher testing. The bolt catcher, shown in Figure 7-1, was not qualified as an assembly, and structural qualification testing was not representative of the current flight configuration. The exact magnitude of loads transmitted to the bolt catcher housing cannot be determined based on available data. The SLA-561 thermal protection system (TPS) material on the bolt catcher was qualified by test and analysis for general ET application, but no pyrotechnic shock testing was performed. There is no test data available on the bolt catcher honeycomb dynamic crush strength versus separation bolt velocity, and random pressure loading from the NASA Standard Initiator (NSI) ejection was not included in the original qualification tests. Lastly, the running torque/break-away torque was not measured during STS-107 bolt catcher fastener and ET range safety system (RSS) fairing installation, which is used to verify the insert locking feature is in place. A review has determined that the bolt catchers and RSS fairings were installed and secured for flight with the correct bolts and final torque. Testing is in work to close the four remaining fault tree blocks, but initial static tests results show failure below the required safety factor of 1.4.

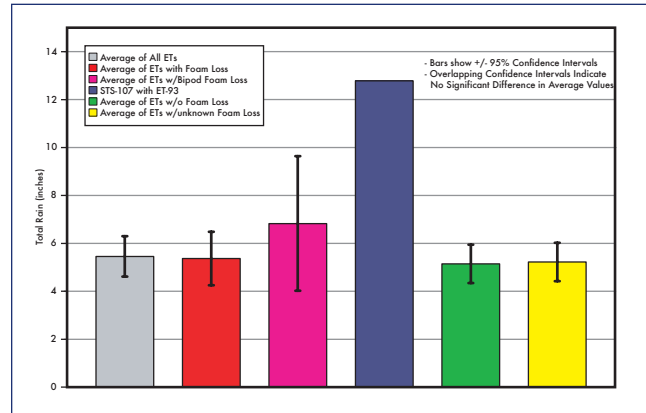
Figure 9-6. Total rainfall for STS-107 compared to total rainfall for missions with and without bipod foam loss.

examined total rainfall, maximum one-day rainfall, average daily rainfall, launch day rainfall, and L-5 days through lift-off total rainfall. Figure 9-5 shows the total prelaunch rainfall for all STS missions. As shown in Figure 9-6, although the STS-107 value for total prelaunch rainfall, 12.78 inches, is greater than the mean value for all mission, 5.45 inches, the data are inconclusive as to whether a correlation can be

made for ET bipod foam loss as a function of total rainfall prelaunch. The 95% confidence limit of the missions with ET bipod foam loss overlaps the confidence interval for all missions, as well as missions with no foam loss.

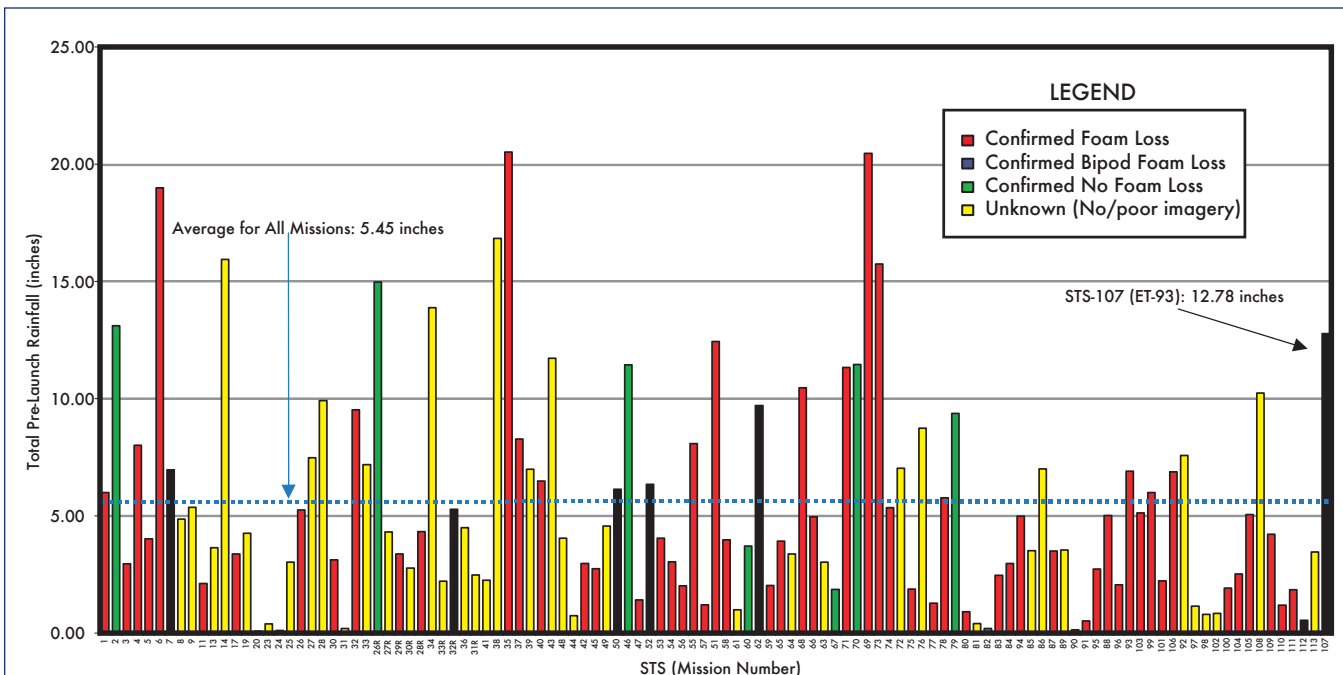
Figure 9-5. Total prelaunch rainfall for all STS missions.

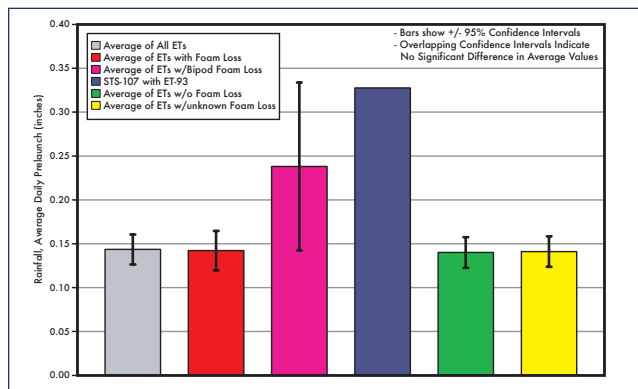
Figure 9-8. Average daily rainfall prelaunch for STS-107 compared to average daily rainfall for missions with and without bipod foam loss (below).

107 value, 0.33 inches, and the mean value for missions with bipod foam loss are greater than the average mission value, 0.14 inches. However, the confidence intervals overlap each other, and the data are inconclusive as to whether average daily rainfall and ET bipod foam loss can be correlated.

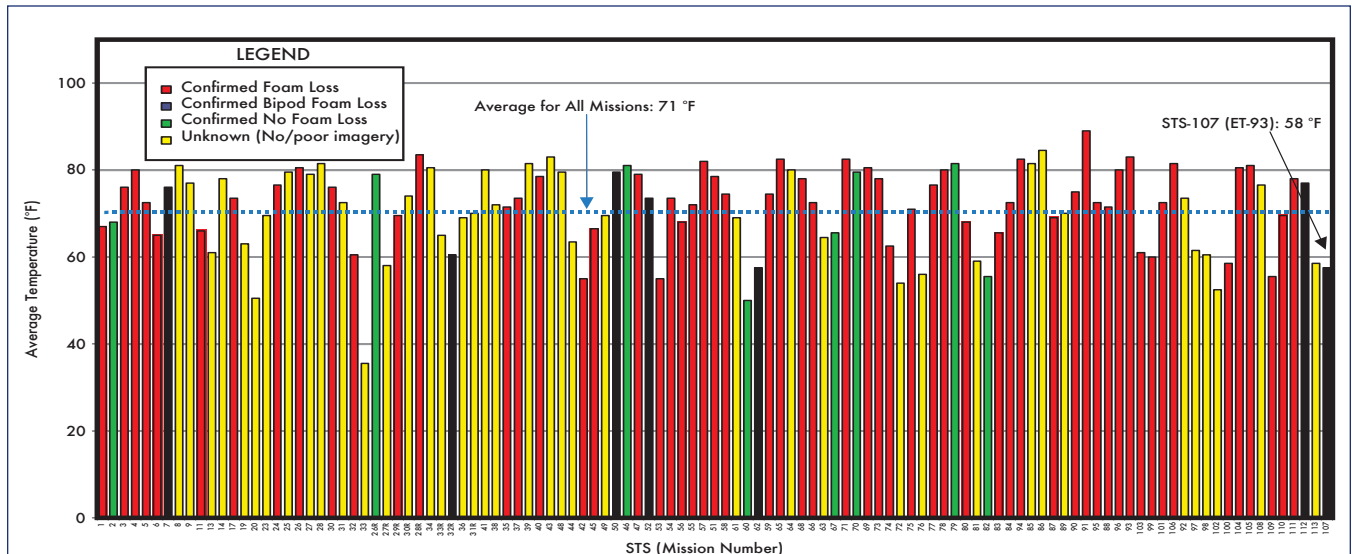
Figure 9-9. Day-of-launch average temperature for all STS missions (bottom).

In addition to rainfall, the study also reviewed average, minimum, and maximum temperature, dew point, and humidity for both prelaunch and day of launch. Figure 9-9 shows the day-of-launch average temperature. The STS-107 day-of-launch average temperature, 58 °F, was less than the mean value for all missions, 71 °F, but no correlation can be made between day-of-launch average temperature and ET bipod

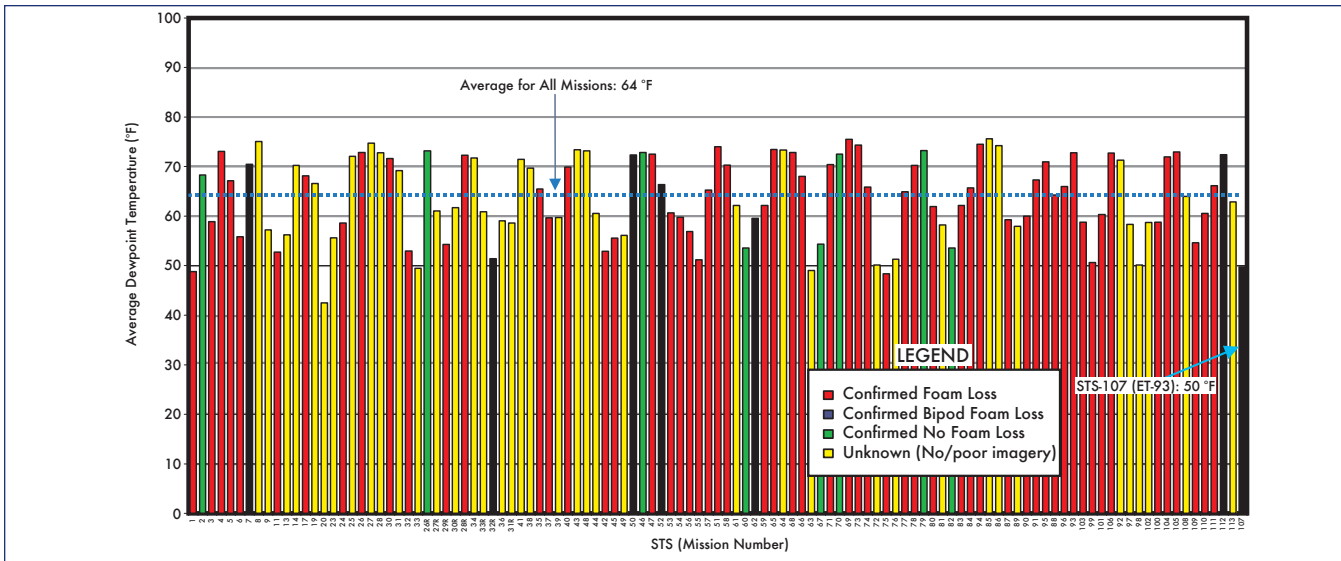
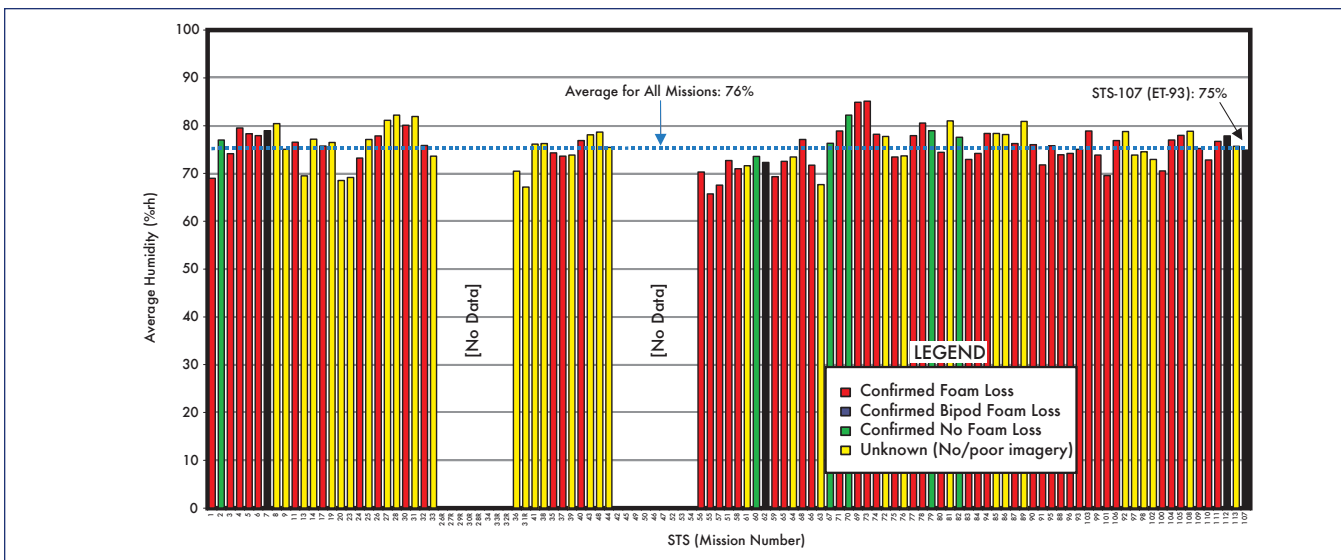
Figure 9-10. Prelaunch average dewpoint for all STS missions (top).

Figure 9-11. Prelaunch average humidity for all STS missions (above).

foam loss. Similar comparisons made for other temperature samplings, dew point (Figure 9-10), and humidity (Figure 9-11), yielded no correlations either.

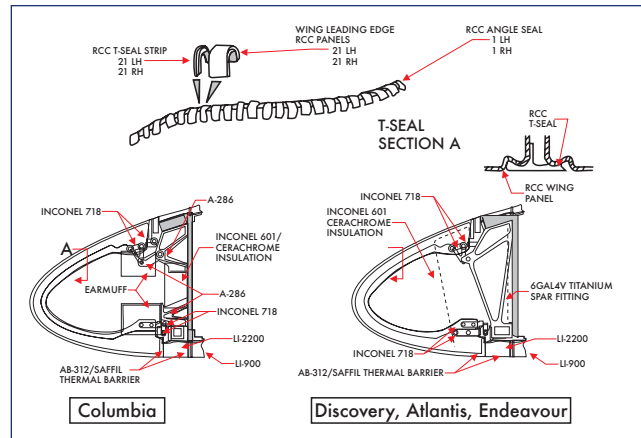
Figure 10-4. Wing leading edge RCC.

The angle seal at RCC panel 1 on the left wing leading edge (see Figure 10-4) was removed to support the evaluation of the horse collar gap filler between the adjacent tiles. During the removal attempt, the upper bushing remained bound with the shipside clevis. During subsequent attempts, the angle seal was manually manipulated to try and remove the preload. During the KSC paper review, structures engineers realized that the load applied to the angle seal was specified to be kept below 20 pounds, but was never recorded in the

paper. The RCC specification requires that RCC panel loads be kept below 30 pounds. Subsequent tests at KSC verified that the angle seal load was below the 30-pound requirement. The LESS prevention and resolution team is addressing the issue of how to measure the load and how to support the seal in future operations. Work continued on the elevon flipper doors. Flipper door 1 blade seal was not making contact with the rub channel, potentially leading to excessive venting from the elevon cove area. This issue surfaced twice during this flow and was Material Review (MR) accepted to fly as is. Modification was made to the Inconel trailing edge seal and bulb seal on the elevon. Additional work was performed on the elevon cove corrosion protection again to reduce the excessiveness of the application.

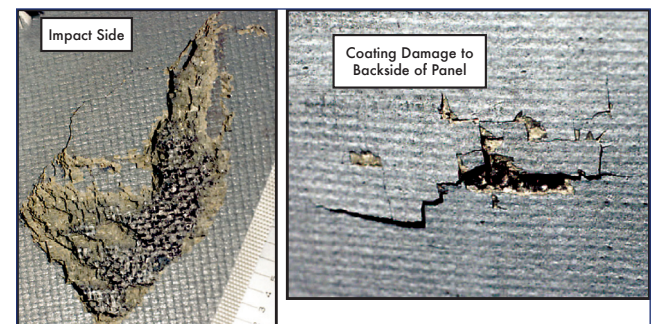
There have been damaged RCC panels that were discovered after the vehicle returned from space on various missions. Some of the impact damage was only to the surface, but some even caused damage to the coating on the backside of the panel. In 1992, after STS-45, significant impact damage (overall length of ~1.75 inches) was noted on RCC panel

Figure 10-11. RCC impact damage.

10R on *Atlantis*. The damage (Figure 10-11) was theorized to come from orbital debris or micrometeorite impacts during the mission. This type of RCC damage is of particular concern in that a significant impact could cause a hole in the RCC large enough to lead to wing spar burn through and subsequent loss of crew and vehicle. At that time, the maximum acceptable hole size (0.040") criterion was established for processing flows and advanced wing leading edge internal insulation was modified to reduce the risk should hot gas penetrate the RCC.

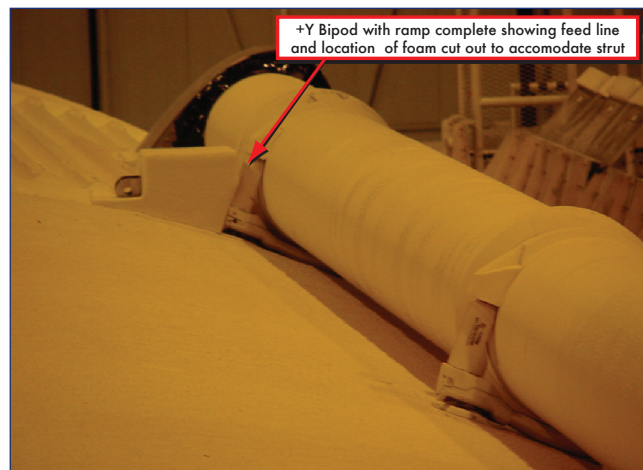
There is no flight or test data to explain why the –Y (left) bipod loses foam and the +Y (right) does not. The Shuttle Program only provides the –Y ramp air loads as a worst case for ET project analysis. There are several bipod configuration differences that may contribute to foam not coming off the +Y ramp. First, the foam ramp is configured slightly differently to accommodate the inboard strut for the LO2 feed line support structure (see Figure 11-2). Second, the proximity of the right bipod to the LO2 feedline could potentially influence local surface pressure causing a lower internal to

Figure 11-2. Right (+Y) bipod ramp.

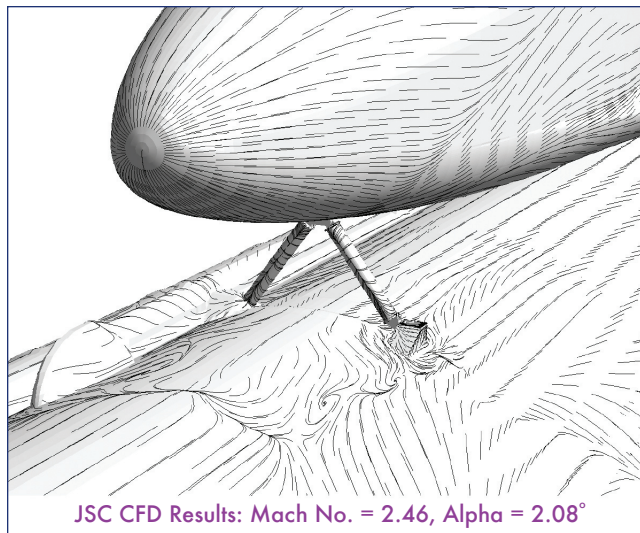
external pressure differential (see Figure 11-3). Finally, the outboard and aft facing surface of the -Y bipod may experience lower surface pressure due to flow separation and other local effects relative to the +Y side. If the internal ramp pressure was high due to adverse “as-built” features in the ramp, this could lead to a higher differential pressure on the -Y versus the +Y ramp. However, the aerodynamic loads analysis reviewed in Section 3.5 shows that the loads on both ramps are below their design requirements.

Figure 11-3. Left and right bipod ramp flow differences, CFD results.

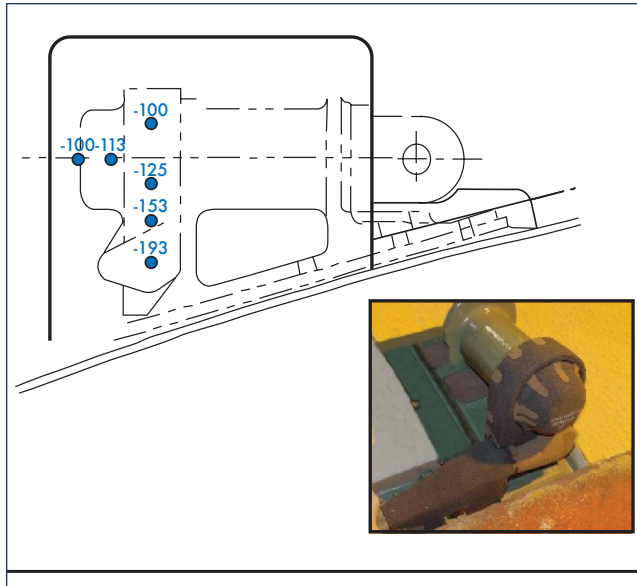
Figure 11-10. Max bipod SLA temperatures (80 seconds MET), °F.

The maximum SLA temperatures possible at 80 seconds were analyzed to determine maximum worst-case multi-event material loss. No cryopumping or cryo ingestion was assumed in order to calculate temperatures as high as possible. STS-107 ambient environments were used. Results showed the maximum SLA temperature possible at 80 seconds MET is less than or equal to  $-100^{\circ}\text{F}$ , as shown in Figure 11-10. Tension testing shows BX-250 fails before SLA at temperatures less than or equal to  $-100^{\circ}\text{F}$ .

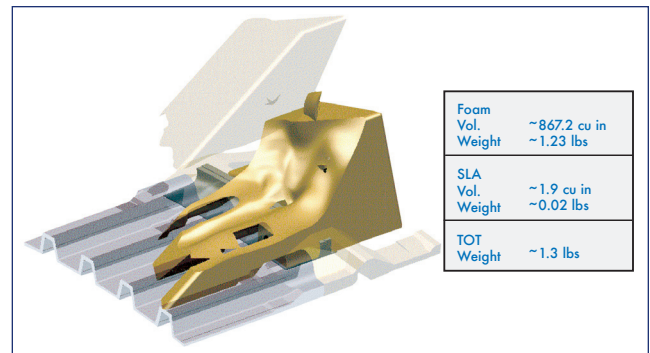
The ET Working Group conducted an analysis coupled with test data to estimate a multi-failure mode TPS bipod debris size and weight. The ET Working Group scenario includes seven simultaneous and interactive adverse events: A large rollover occurs at the inboard stringer interface immediately below the machined foam surface, side-to-side thermal crack/weak knit line, a large void near the topmost surface one inch below machined foam surface, warm SLA environment, and foam machined to minimum tolerances (not a failure). The specific results are shown in Figure 11-13.

Figure 11-13. Multi-failure mode bipod TPS debris estimated by the ET Working Group. Note that this size and weight were not used in the RCC impact testing as part of the STS-107 investigation.

The determination of the STS-107/ET-93 bipod TPS debris is based on evaluation of fault tree findings, possible TPS failure modes and contributors, and results to date from TPS debris test programs including dissection, foam loss secondary effects assessment (SLA/BX-250), and bipod TPS debris size analysis. The TPS bipod debris size was determined by the ET Working Group to be approximately 870 cubic inches and 1.3 pounds.
