3.0 PHYSICAL SETTING

3.2 GEOLOGY AND SOILS

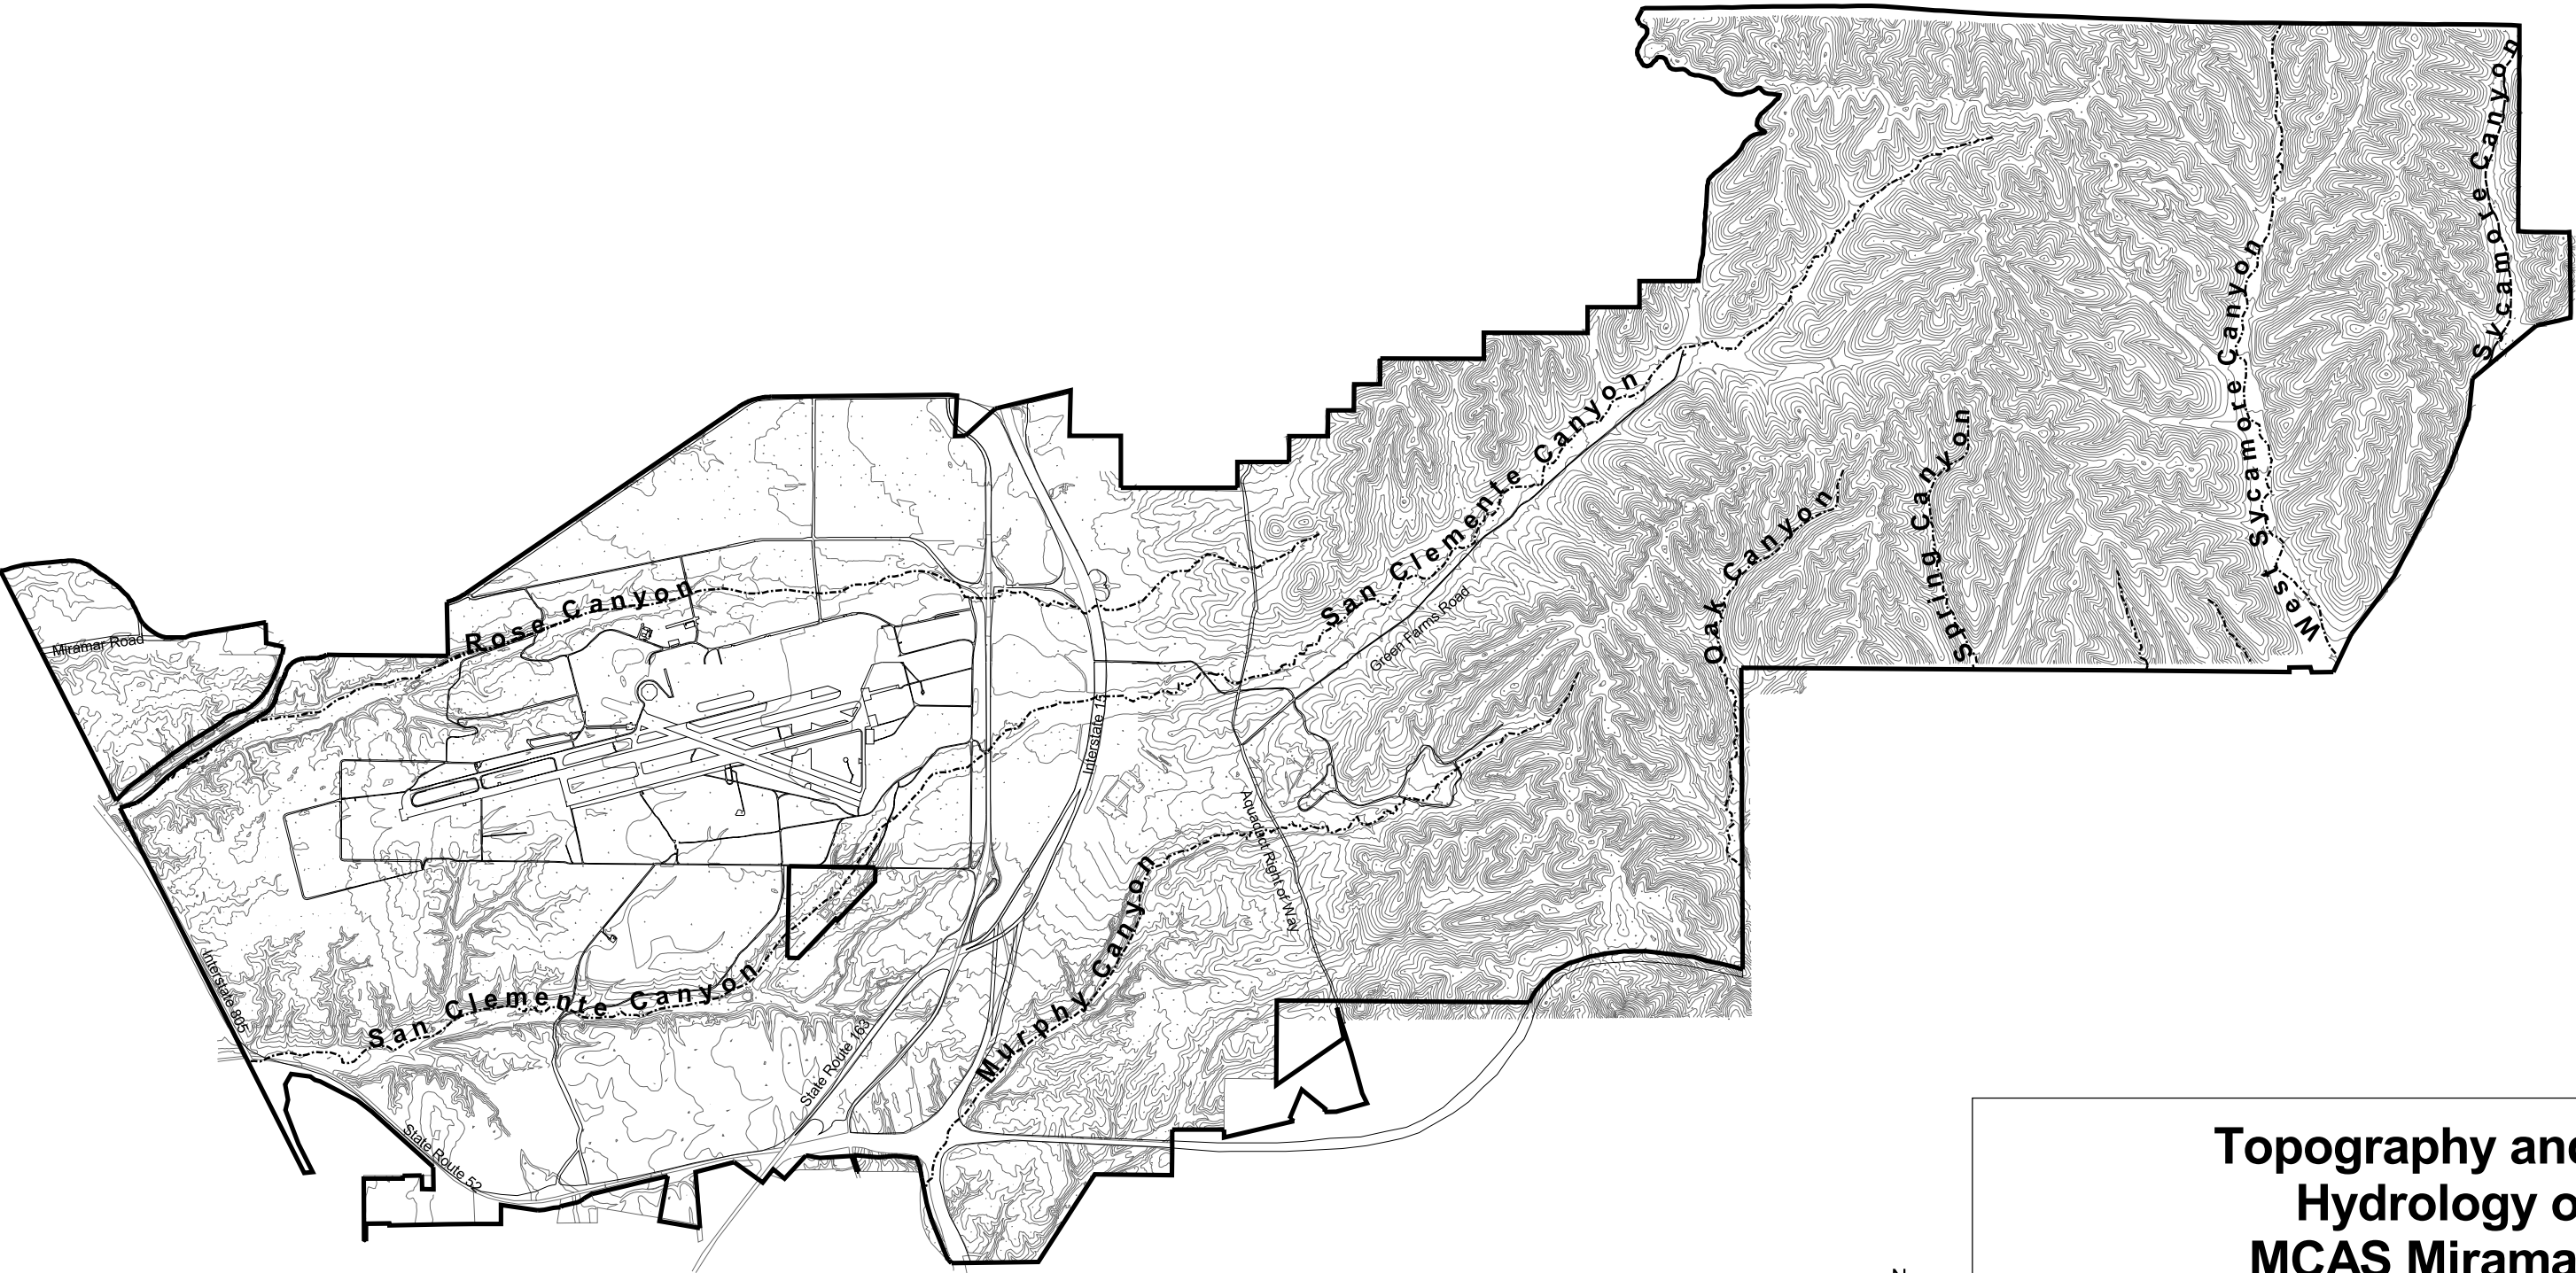
Note: Contour interval on topography is 20 feet west of Interstate 15 and 25 feet east of Interstate 15.

**Topography and
Hydrology of
MCAS Miramar**

Steep, eroded, gravelly, or cobbly terraces consisting of the Poway group of non-marine sandstone and coarse cobbly "Stadium" conglomerate predominate the upland areas of East Miramar. The conglomerate is overlain by softer, more erodible tongues of marine, lagoonal, and non-marine sandstone called the Mission Valley Formation, which is then overlain by Pomerado conglomerate (Figure 5) (Kennedy 1975). This area is highly dissected, with rugged divides, dendritic drainages, and V-shaped valleys (Figure 6).
